## Introduction

Stratford Point (Fig. 1) was home to Remington Arms Gun Club, a trap and skeet shooting range from 1926 to 1986. Years of shooting resulted in lead contamination in the intertidal zone from the accumulation of lead shot. The 12 acres of intertidal habitat on site historically supported a tidal fringe marsh which was degraded by remediation activities that included the removal and separation of shot from intertidal vegetation and sediments. Prior efforts to restore the intertidal marsh failed due to storm events.

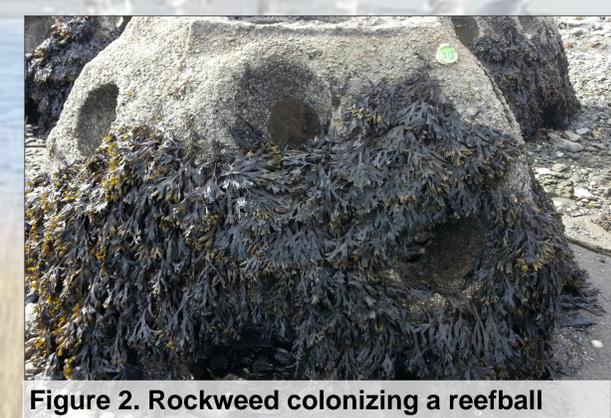
Figure 2. Rockweed colonizing a reefball

- A 150 ft. artificial reef structure consisting of 64 Reef Balls® was installed in May 2014 (Fig. 2) and 273 more were placed in November 2016.
- Over 3,500 *Spartina alterniflora* plants were planted directly behind and to the southwest of the reef in June 2015 (Figure 4 & 5).
- Deployment of pressure sensors prior to storms in winter 2014 to test any decrease in wave intensity as waves pass through Reef Balls (Figure 3).

- Aquatic invertebrate, macroalgae and fish are living in or on the reefballs.
- *Spartina alterniflora* has successfully taken root shoreward of the reef.
- Sediment is accumulating landward and seaward of the reef allowing the salt marsh grasses to triple in size since planting.
- A 30% decrease in wave intensity has been observed during storm events which has halted erosion both behind and in front of the reef.
- Decreasing wave height linked to increasing amount of sediment deposition.

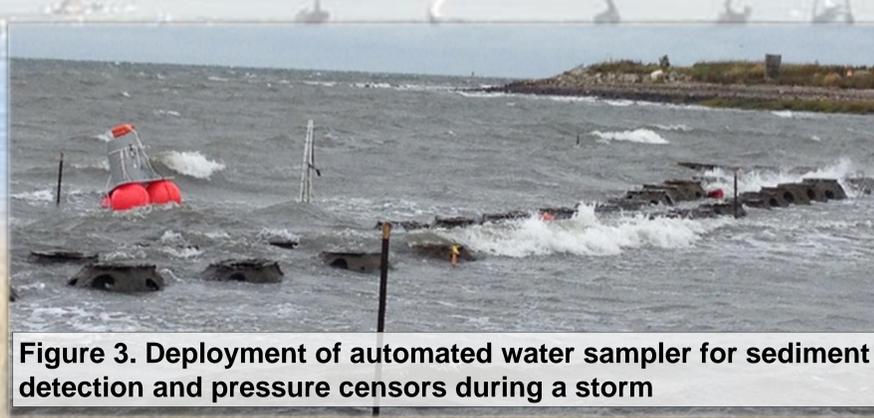
Figure 3. Deployment of automated water sampler for sediment detection and pressure sensors during a storm

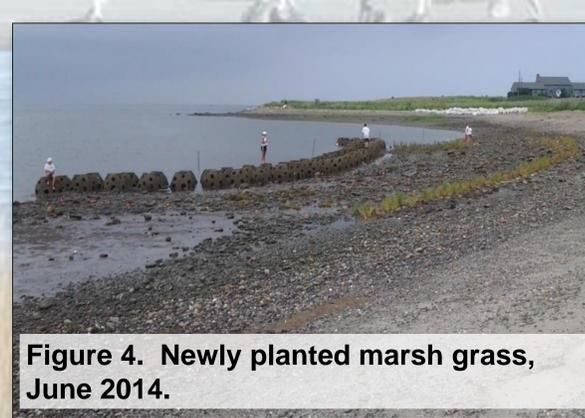
Figure 4. Newly planted marsh grass, June 2014.

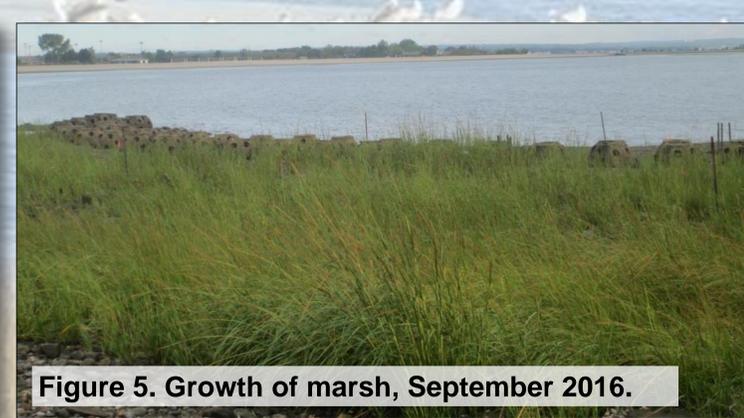
Figure 5. Growth of marsh, September 2016.

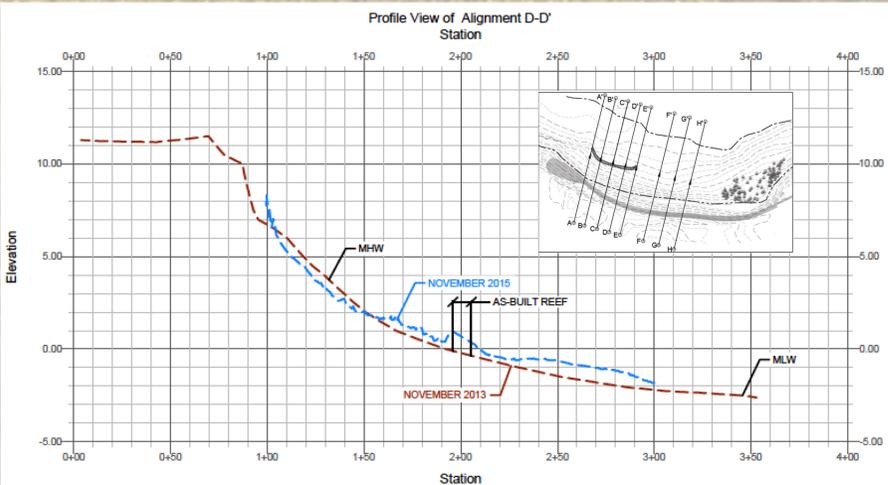
Figure 6. Beach profile through the reef.

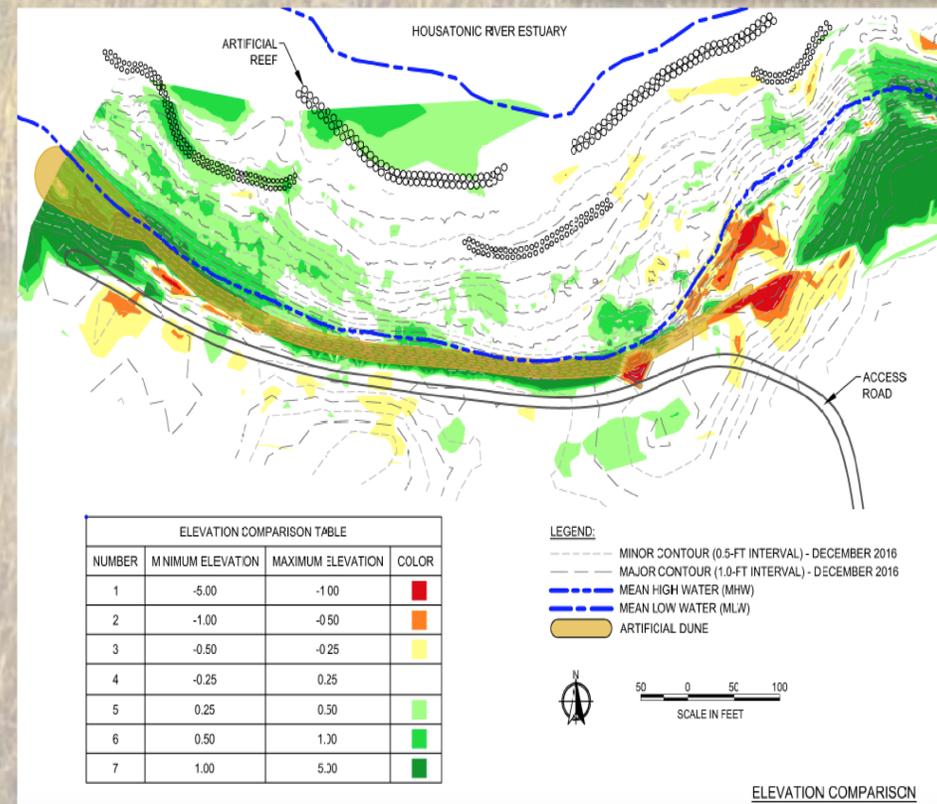
Figure 7. Sediment erosion and accretion & reef expansion, November 2016

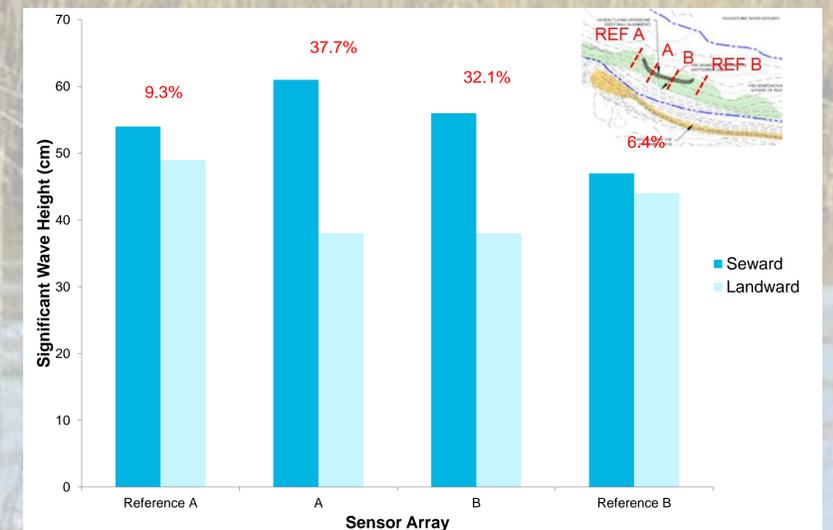
Figure 8. Reduction in significant wave height.
