# Village Creek Harbor & Estuary

A Study on the Feasibility of Restoring  
Degraded Saltmarsh with Dredged  
Material

Public Presentation  
September 7<sup>th</sup> and 9<sup>th</sup> 2017

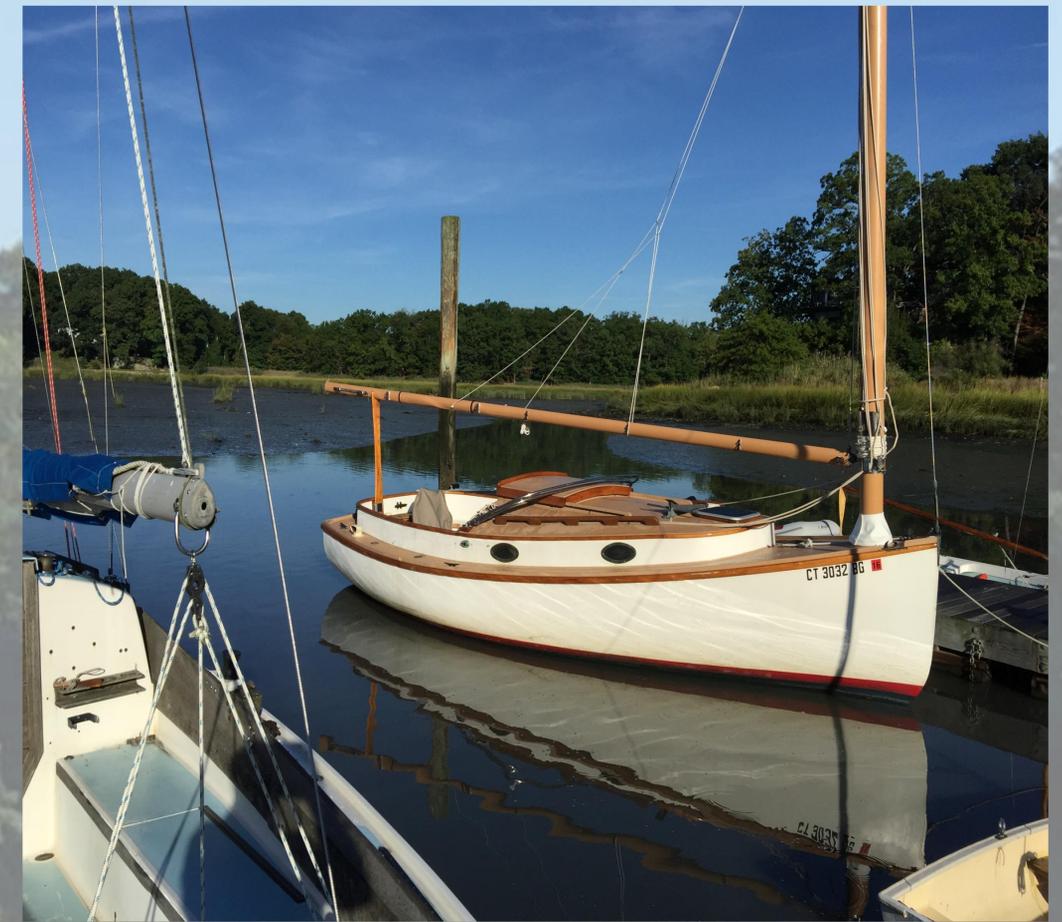
- Small, pleasure boat harbor in Village Creek Estuary.
- Established in 1957. Maintenance dredging on the harbor and/or channel in 1969, 1984, 1992, 1996, 2003, 2010, 2017.
- Funded by Village Creek Community
  - Open to residents and non-residents
- Complete dock renovation in 2010 – Power, water, lights, 49 slips.

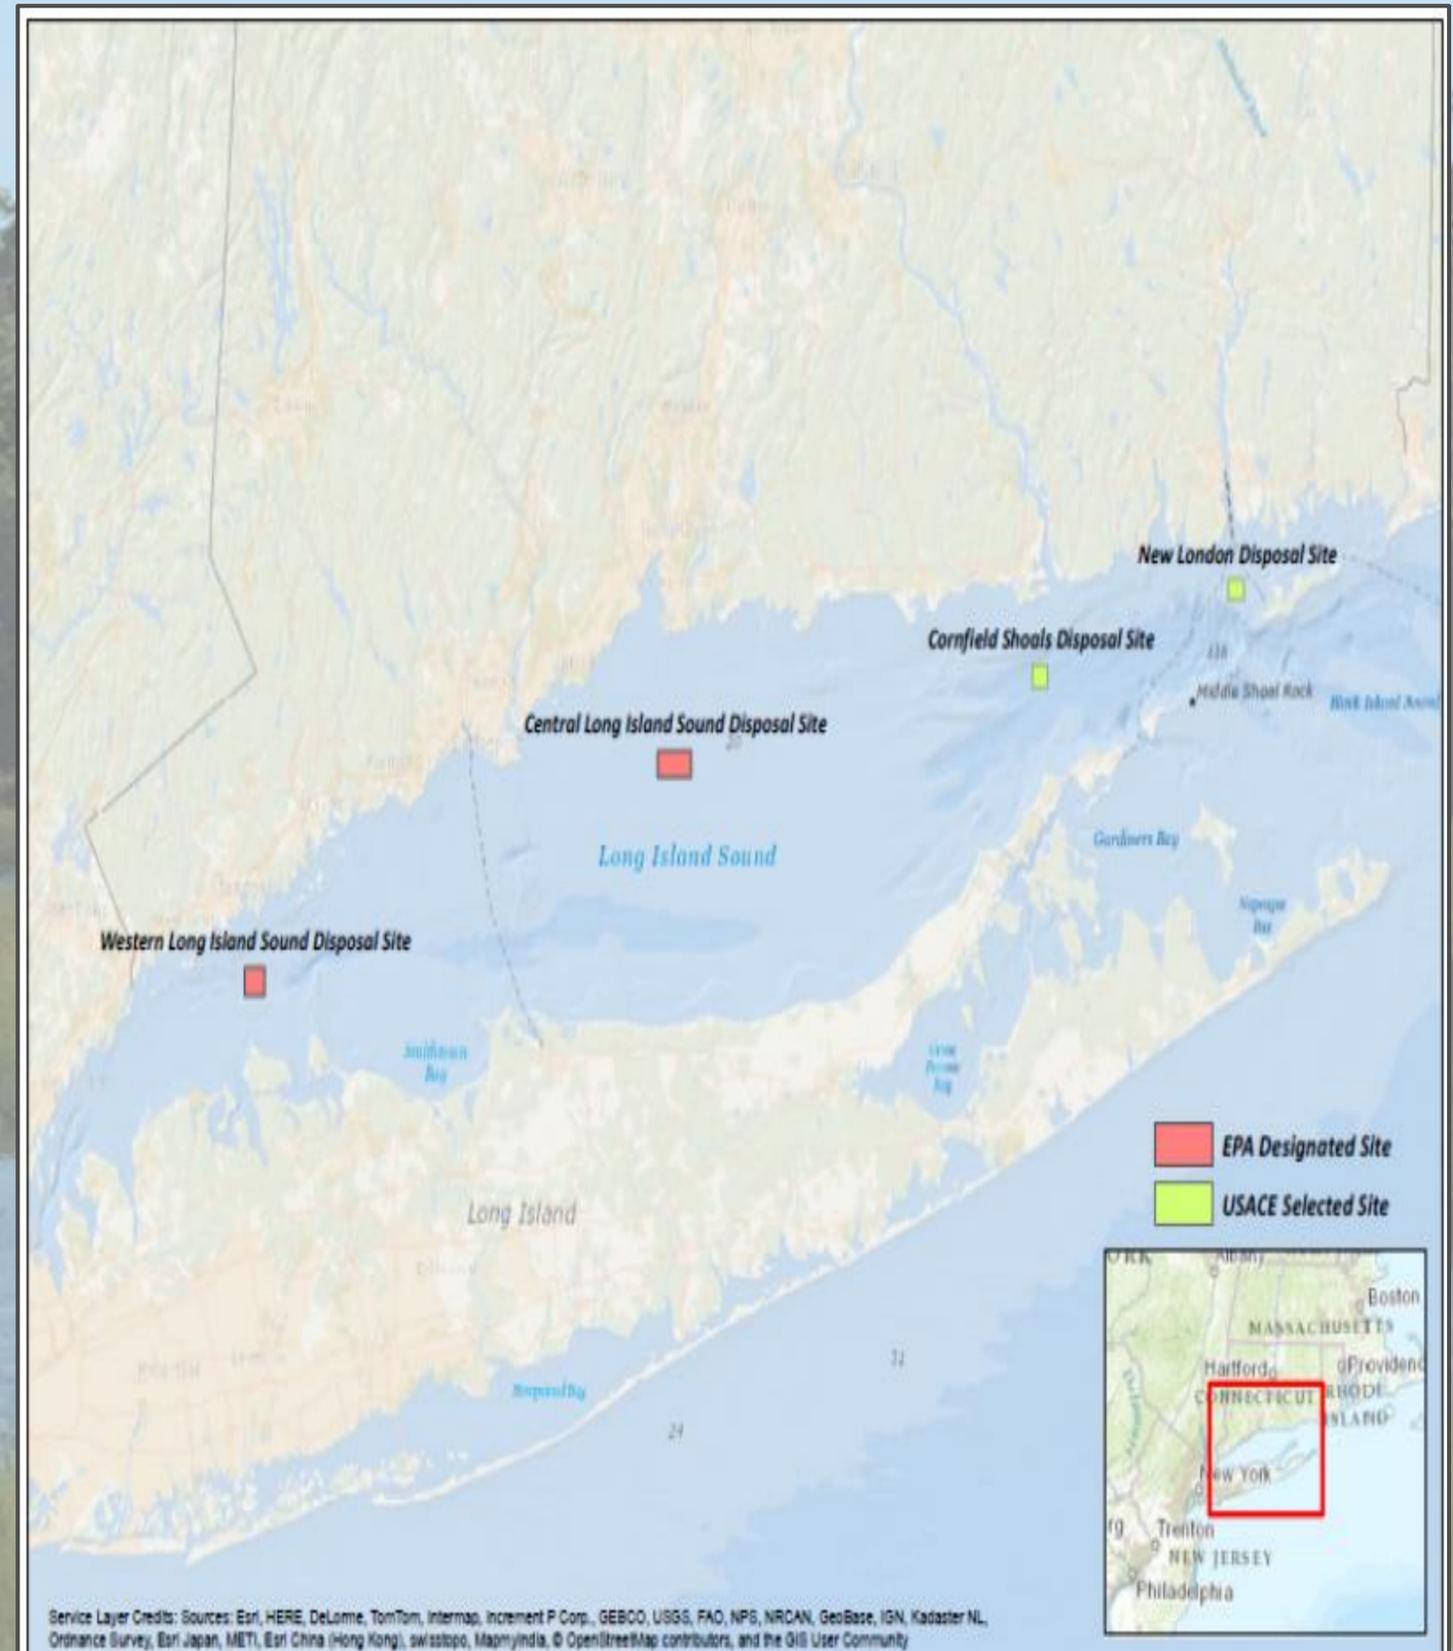
# Harbor and Channel maintained by conventional dredging since 1957.

Village Creek is part of the Long Island Sound Dredge Management Plan (DMMP)

Maintenance dredging on the harbor and/or channel in: 1969, 1984, 1992, 1996, 2003, 2010, 2017

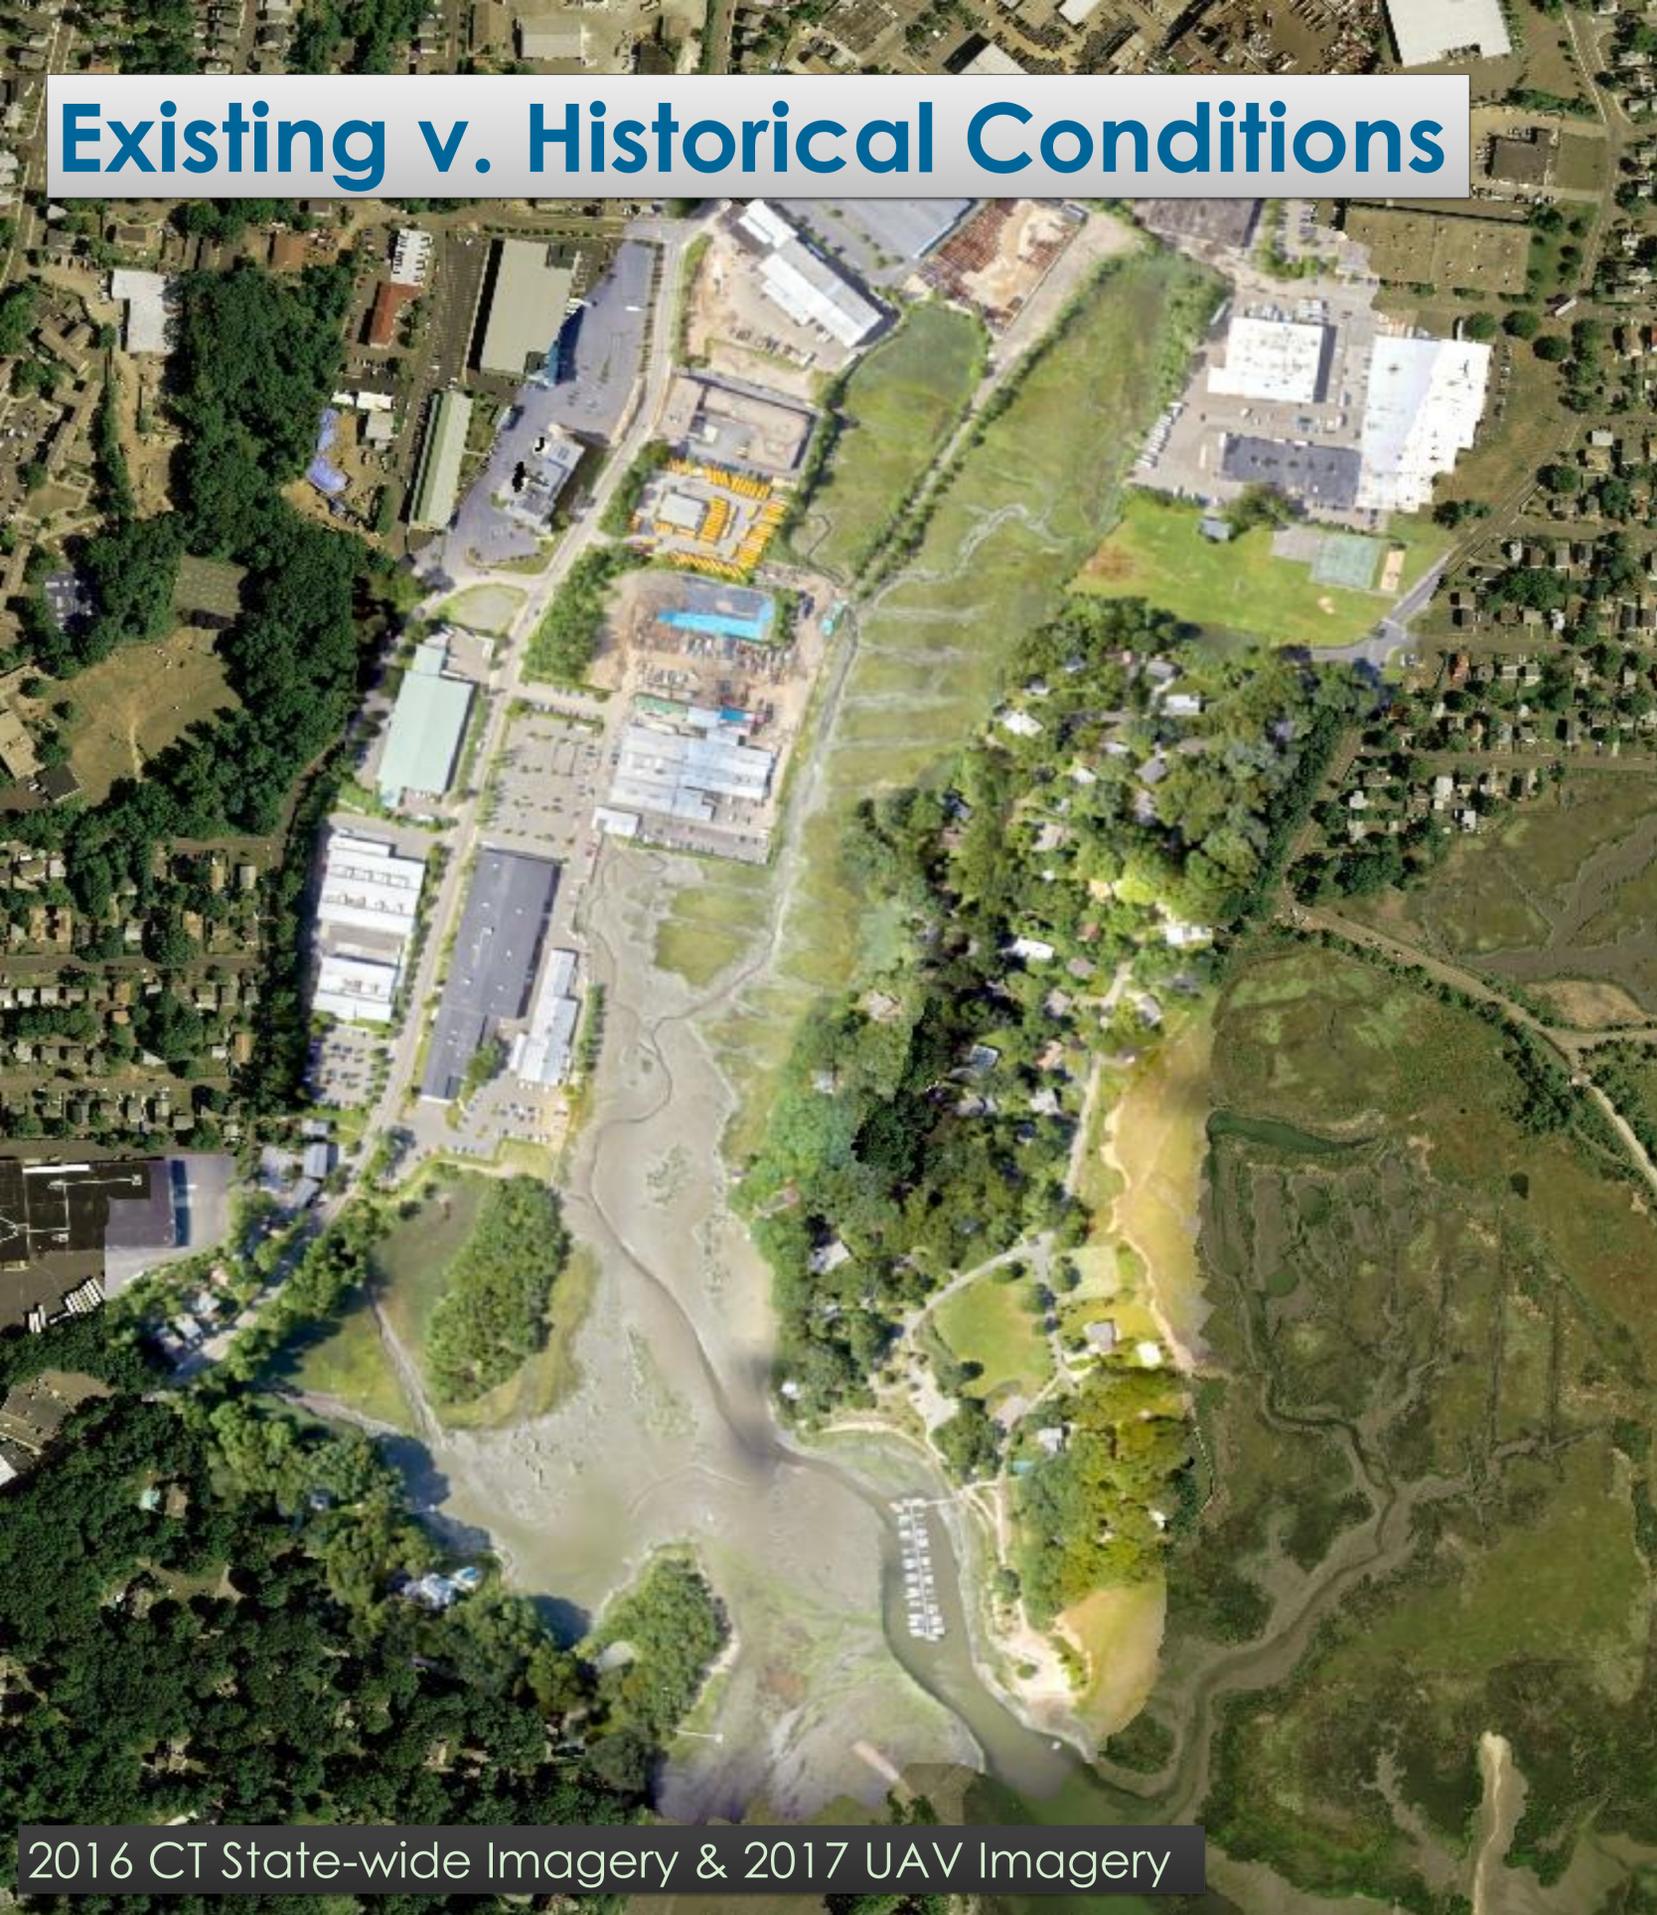
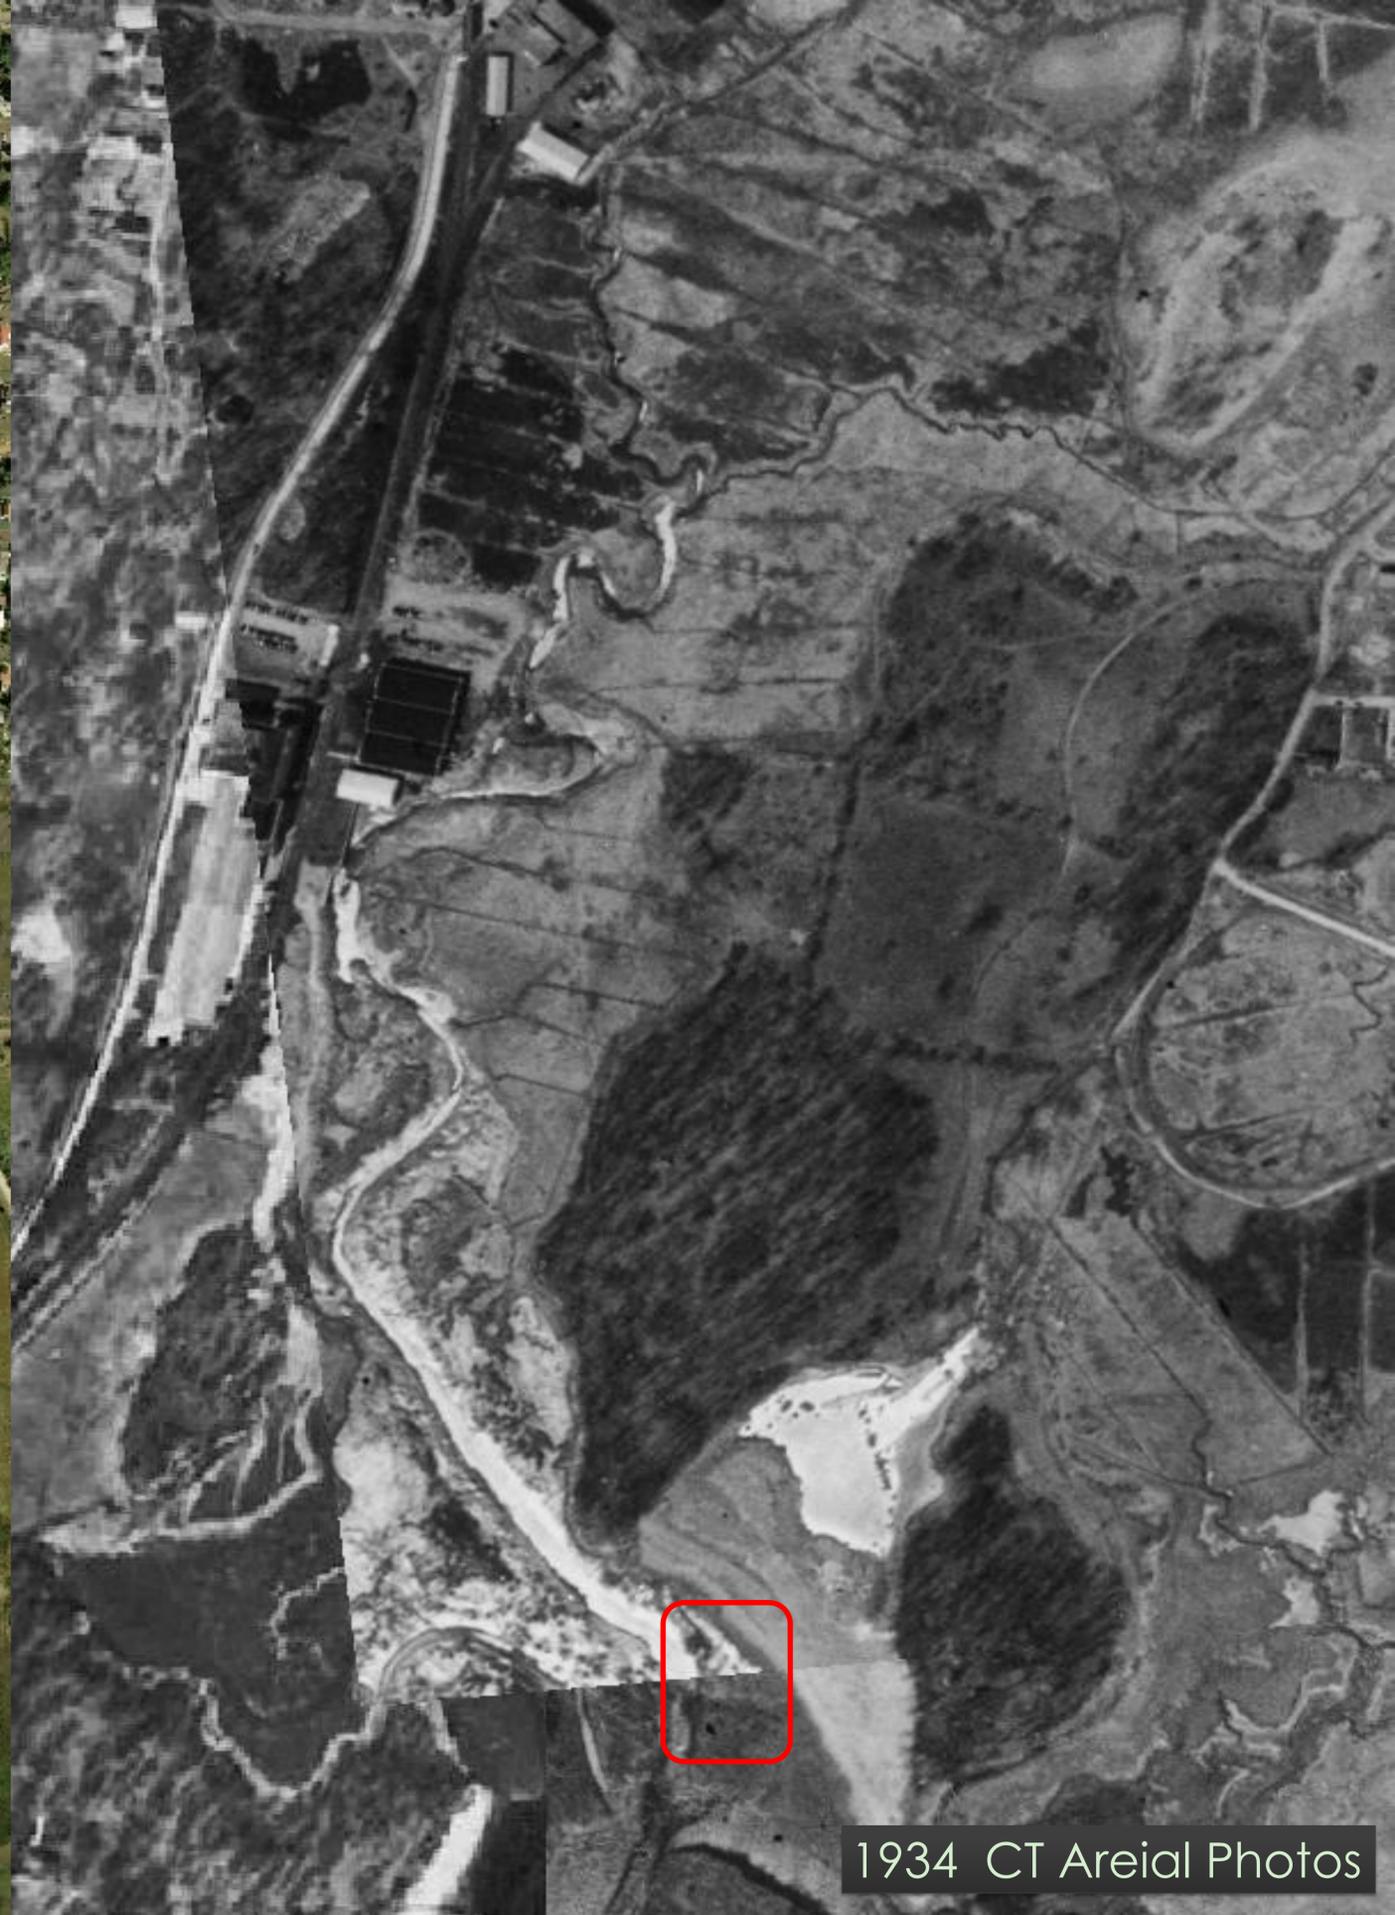
2016 CT State-wide Imagery & 2017 UAV Imagery

1934 CT Aerial Photos

- Village Creek salt marsh exhibits typical conditions for a marsh located in a developed area:
  - *S. alterniflora* dominated
  - Mosquito ditches from 1930s
  - Limited high marsh vegetation communities (*S. patens*)
  - Development of *Phragmites* stands along disturbed edges
- Salt marsh showing signs of degradation including:
  - Extensive areas of stunted *S. alterniflora* on open marsh
  - Development of *Phragmites* stands along disturbed edges
  - Loss of peat density and erosion below the active root zone
  - Increased areas of mudflats (as exhibited by *S. alterniflora* islands)

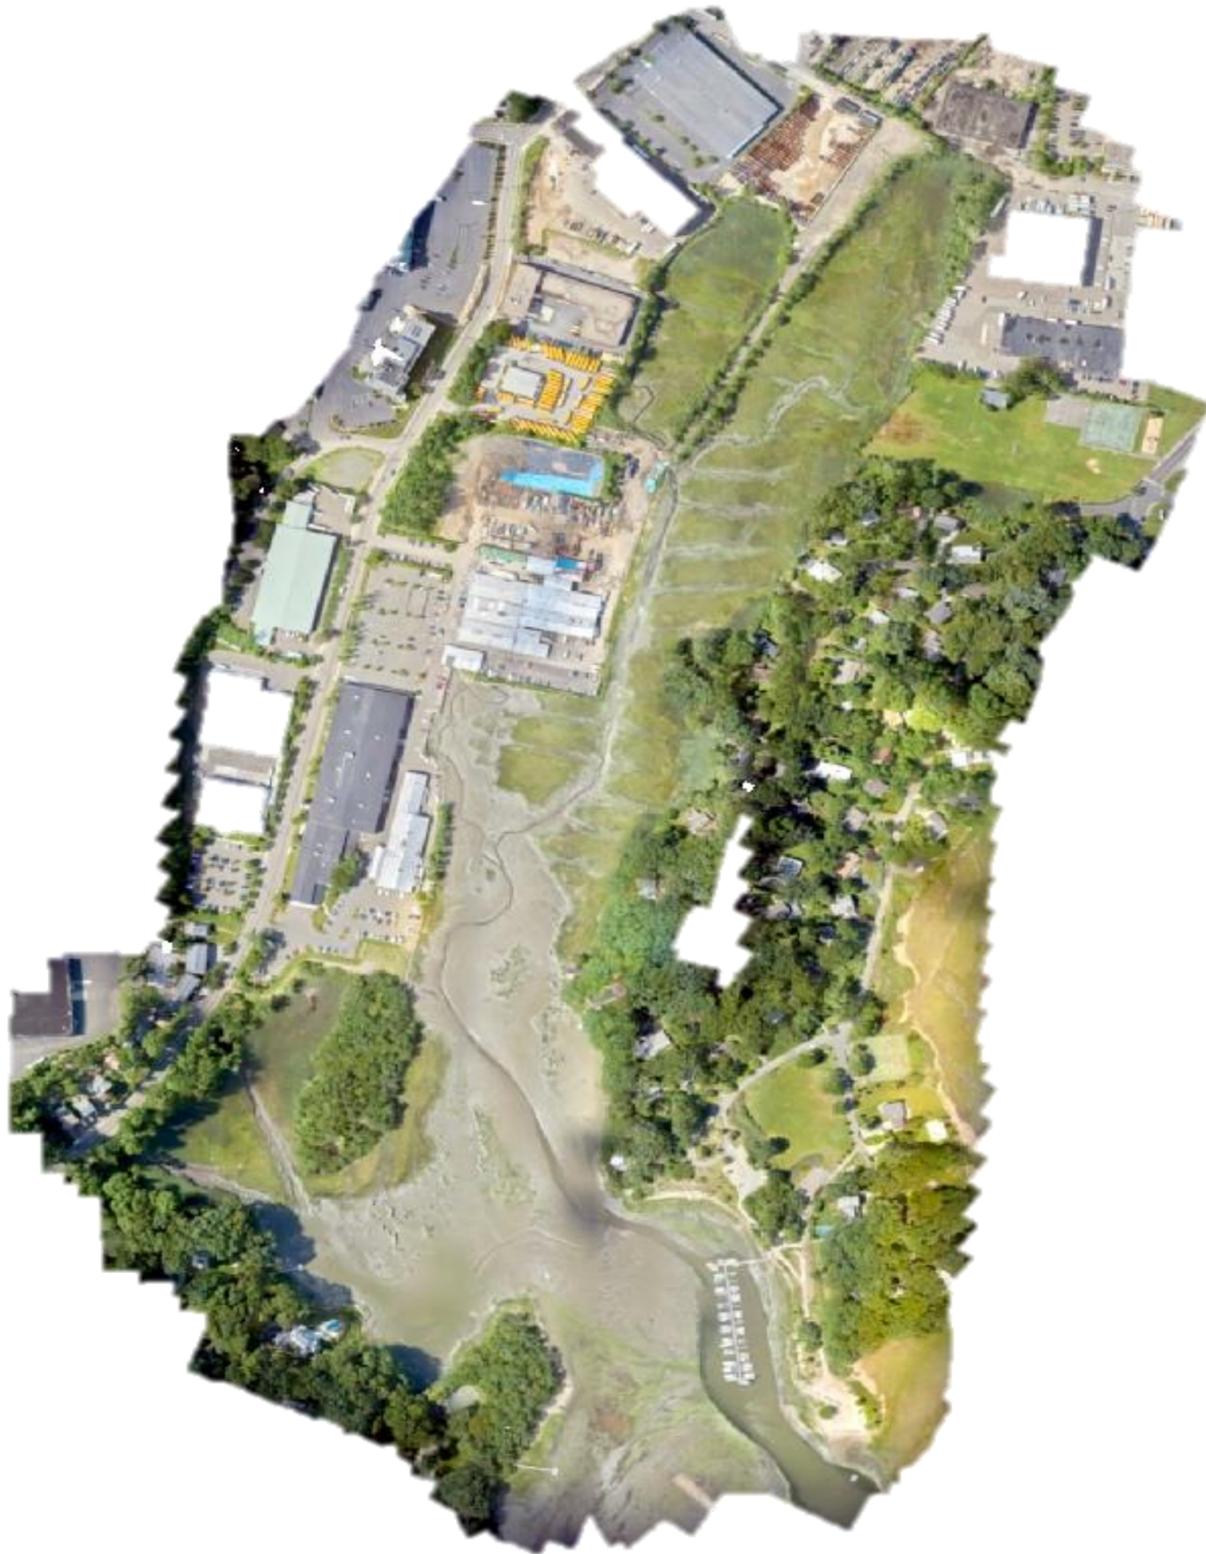
2017 UAV Imagery

# Topographic & Bathymetric Survey

- Control established by traditional survey
- Unmanned Aerial Vehicle (UAV) [Drone]
- Sub-foot vertical accuracy
- +/- 32 acres in one day

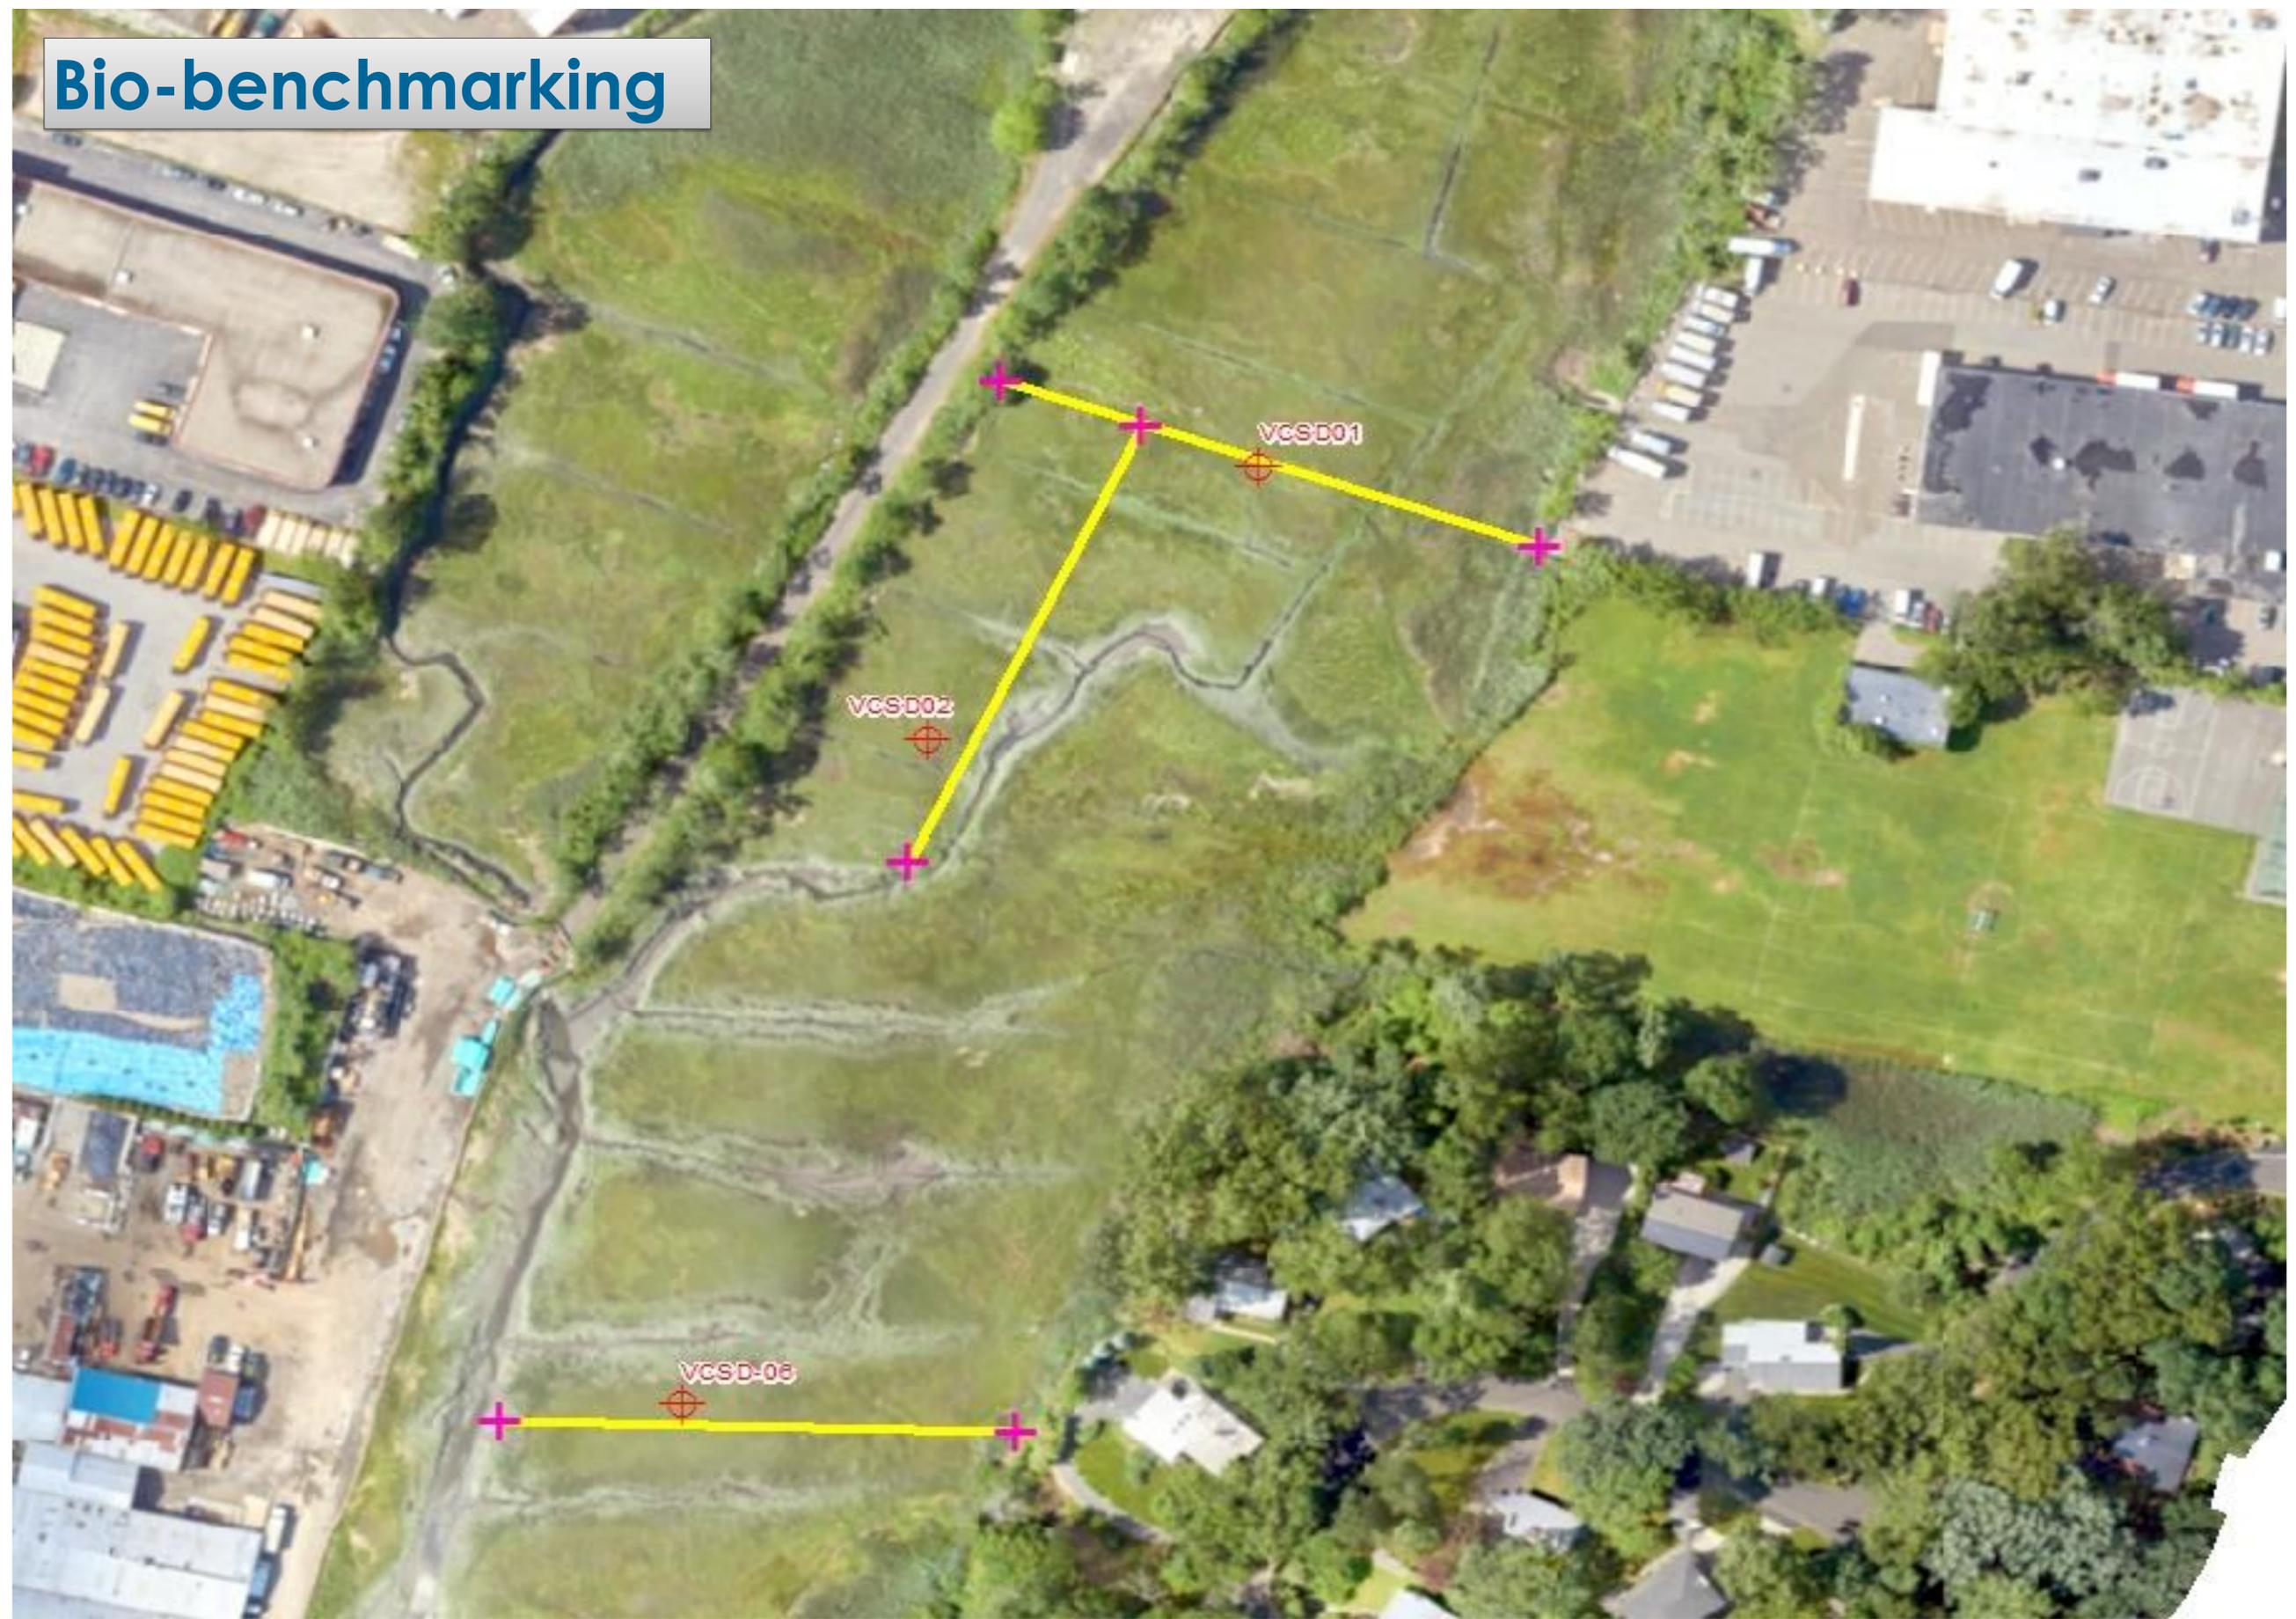
## Vegetation Distribution by Elevation

Village Creek Salt Marsh, Norwalk, CT

- Derive zones (elevation ranges) of existing vegetation communities
- Identify dominant plant communities every 3 feet along each transect
- Evaluate marsh soil for ambient chemical (pollutant) quality and physical characteristics

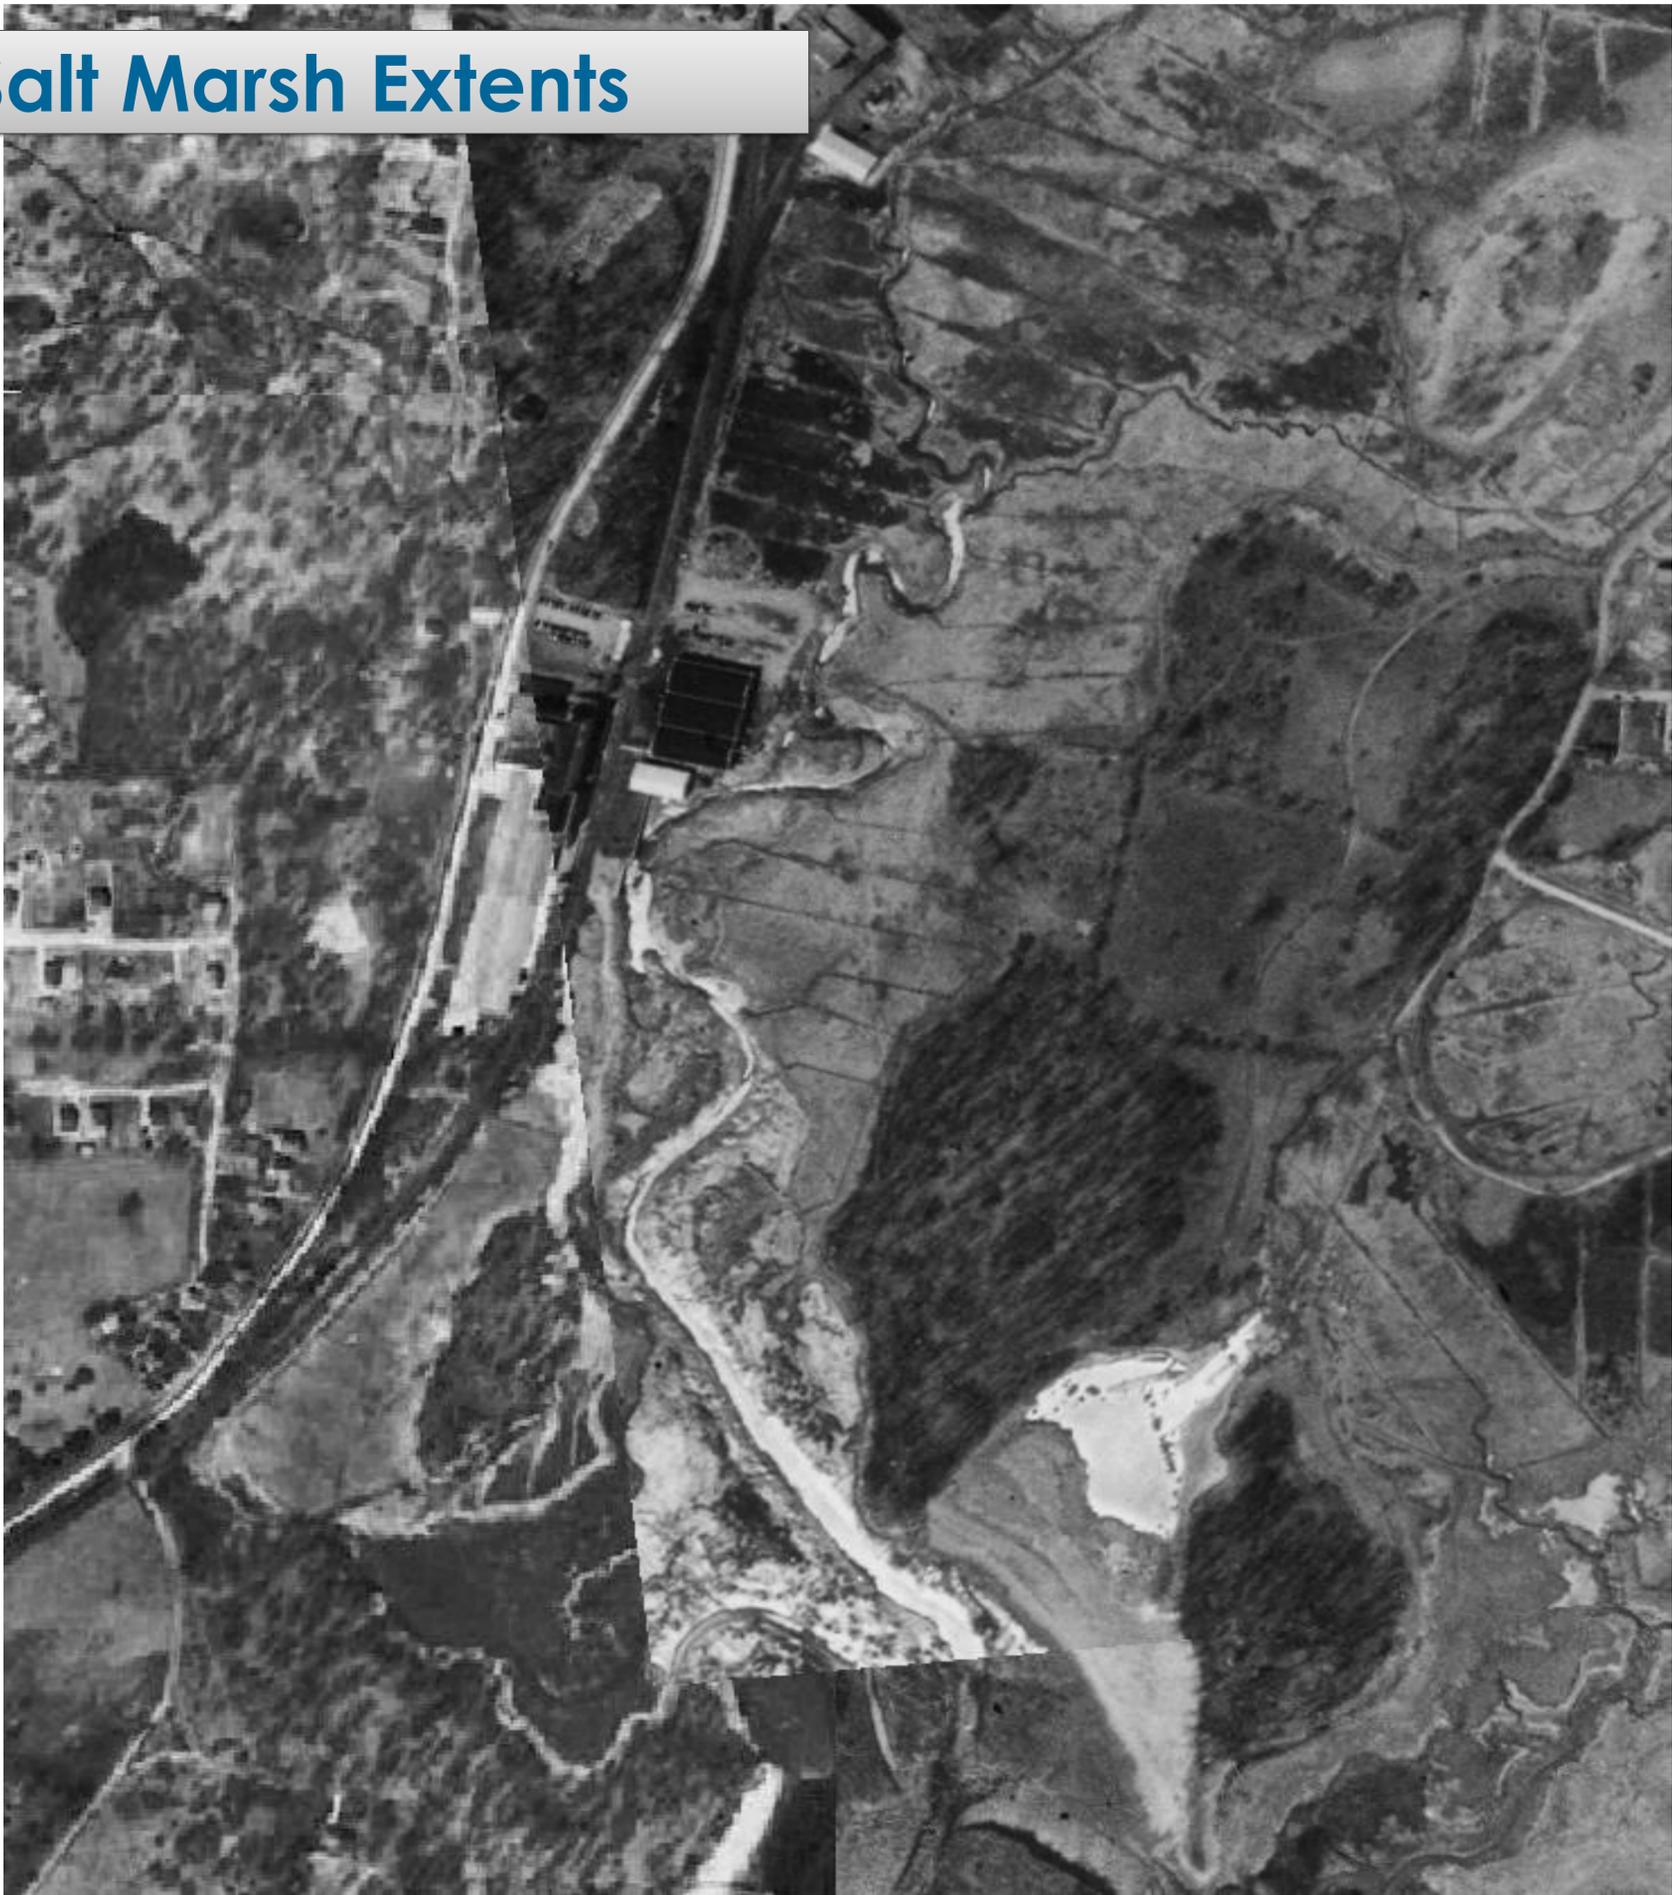
# Historical Salt Marsh Extents

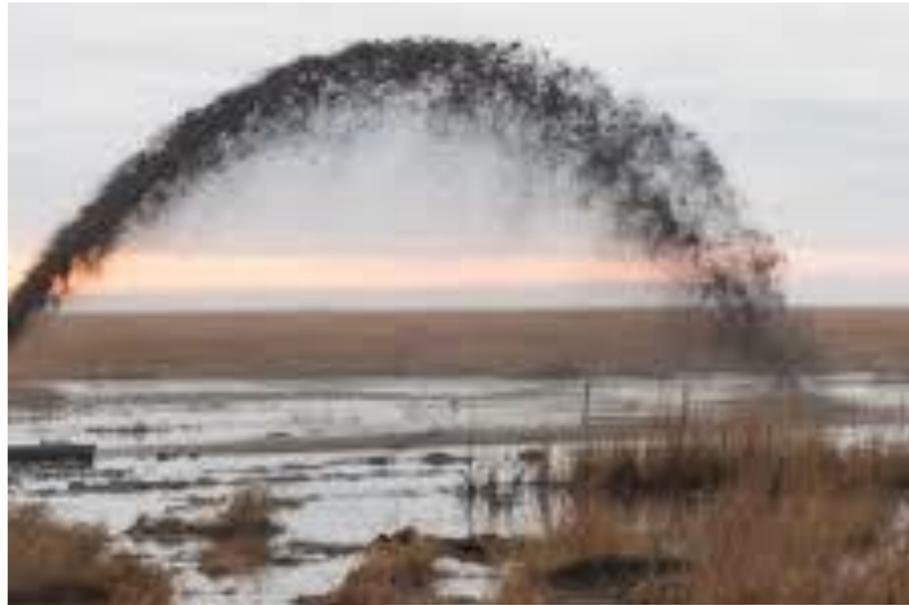
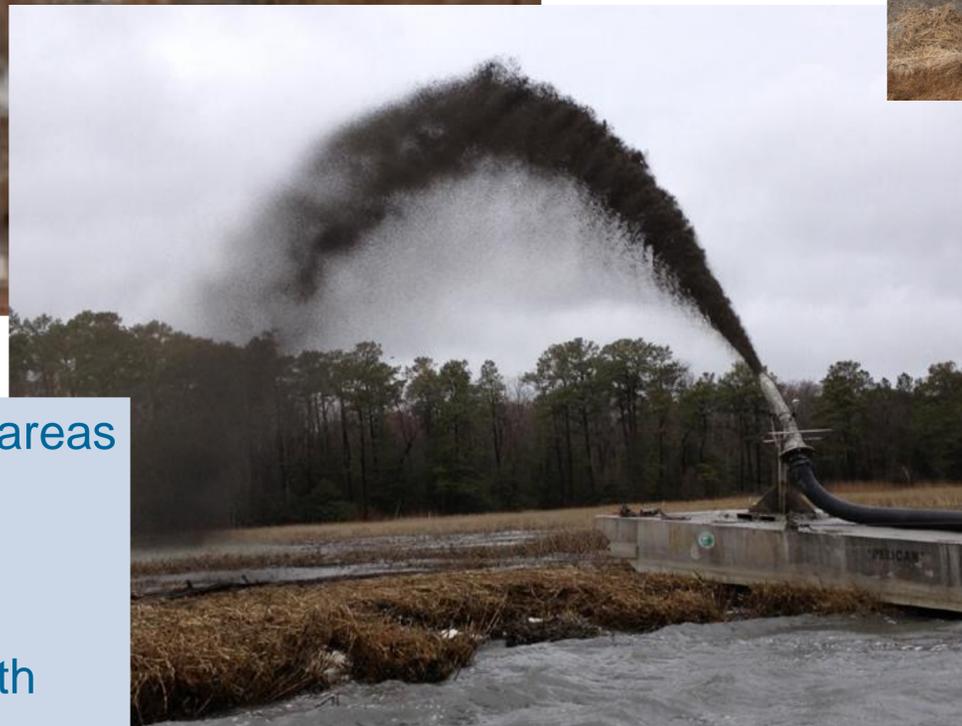
## Spray Application

- Larger volumes/areas
- Finer sediment
- Single process
- Common in South and Mid-Atlantic

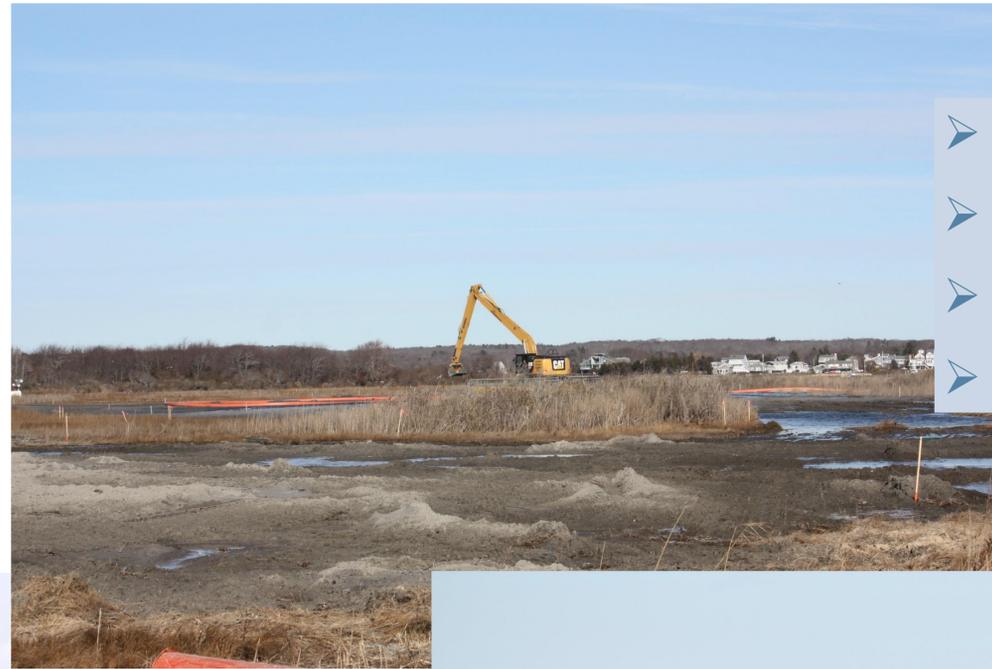
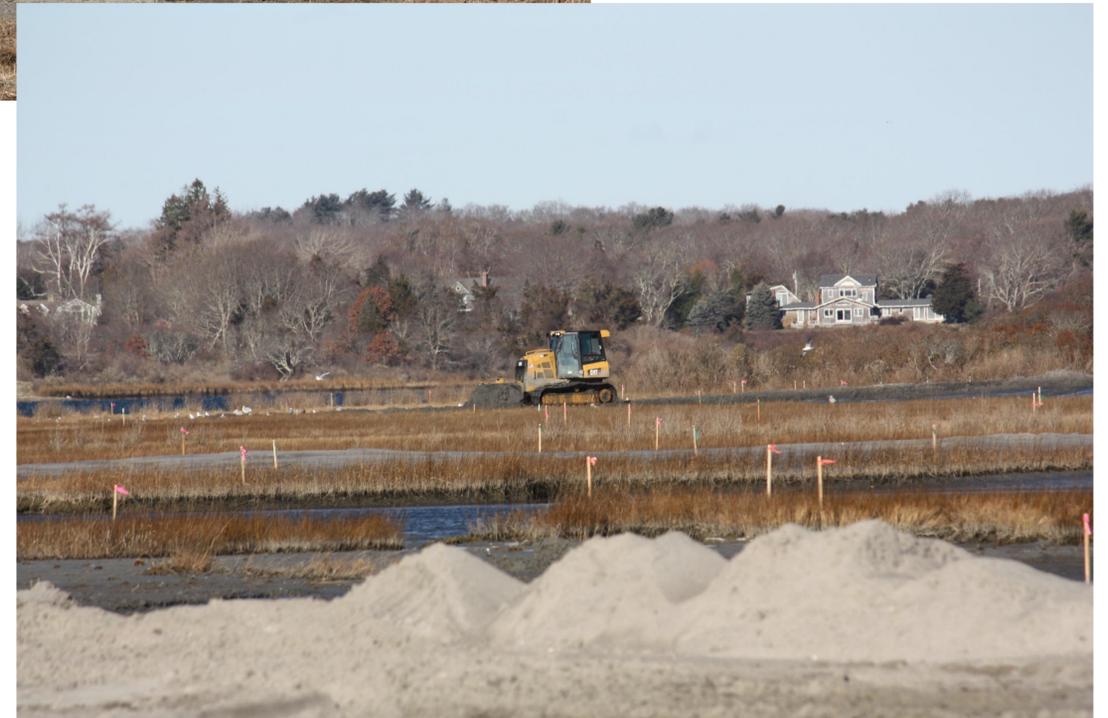
## Mechanical Spread Application

- Smaller volumes/areas
- Coarser sediment
- Multi-step process
- Used in Rhode Island
