Preliminary Engineering Report Holmes Street Seawall – Innovative Design for Climate Resilience

Stonington, CT
April 2023
Revised June 2023
Prepared by Weston & Sampson
For the Town of Stonington

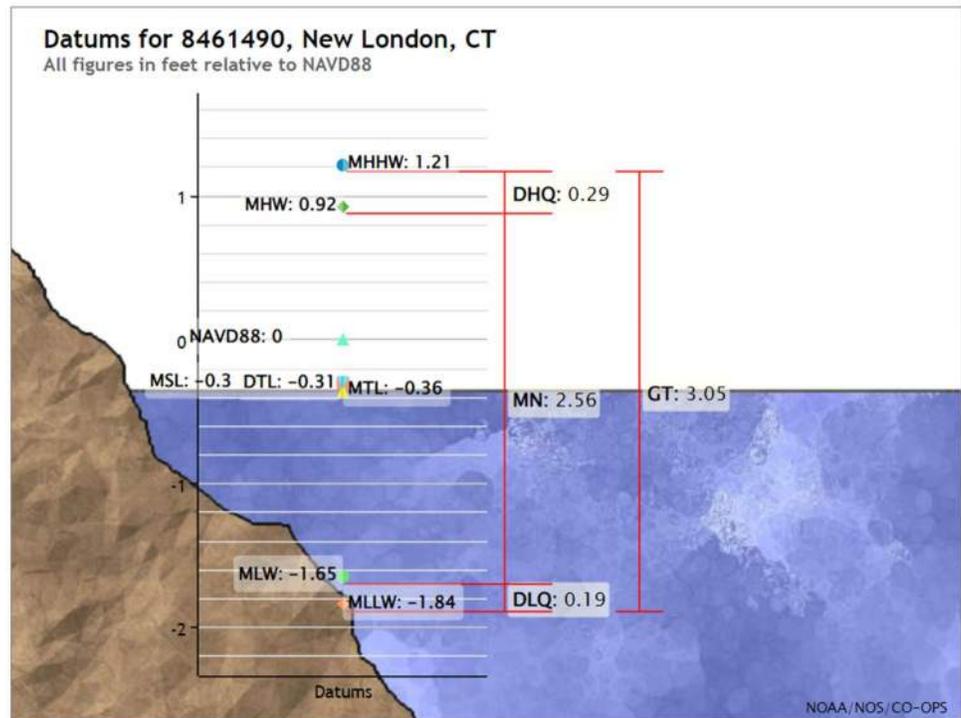
Image 1. Tidal Datums for New London, CT Station relative to NAVD88 Datum (NOAA)

Tidal fluctuations are typically around 3 vertical feet based on the current (1983-2001) National Tidal Datum Epoch (NTDE) for the closest active NOAA tide gauge (New London, CT, Station ID: 8461490), which is approximately 7 lineal miles from the site.¹ *Image 1* illustrates the tidal fluctuations at this tide gauge.

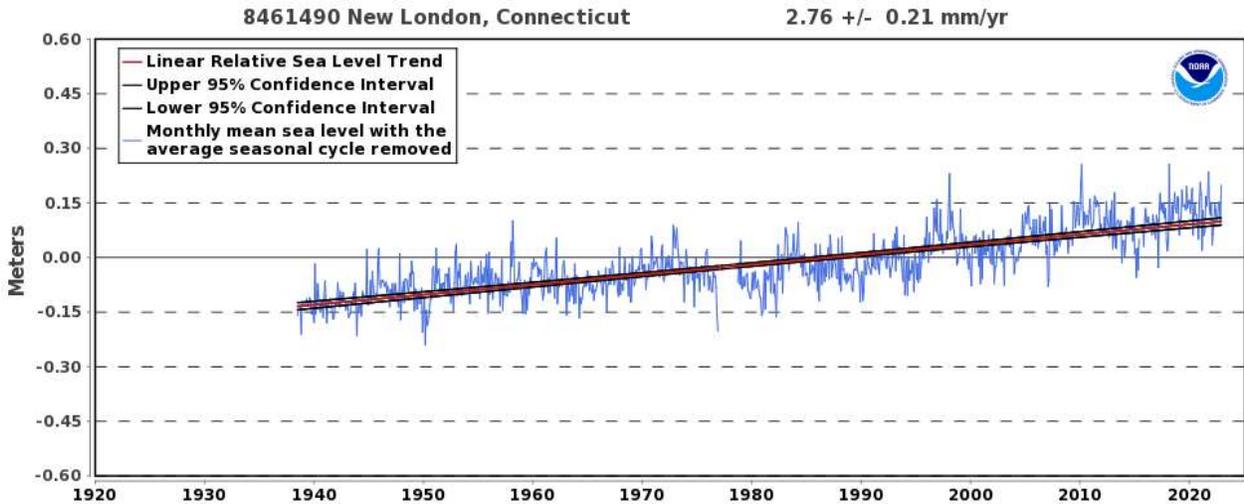
The plot shows monthly mean sea levels relative to the most recent Mean Sea Level (MSL) datum established by NOAA Center for Operational Oceanographic Products and Services (CO-OPS). The trends show a change of roughly 0.91 feet increase in MSL in the past century.

Image 2. Relative Sea Level Trend for Station 8461490 New London, CT (NOAA)

Based on recorded tidal fluctuations since 2002, the monthly average MHHW has been about El. 1.48 and the monthly average MLLW has been about El. -1.55. This indicates a roughly 0.28 foot increase from the NTDE, which reflects measurements between 1983-2001. This is slightly greater than the NOAA recorded relative sea level trend of 2.76 +/- 0.21 mm/year (equating to ~0.2 feet over past 21 years) as shown *Image 2* below.

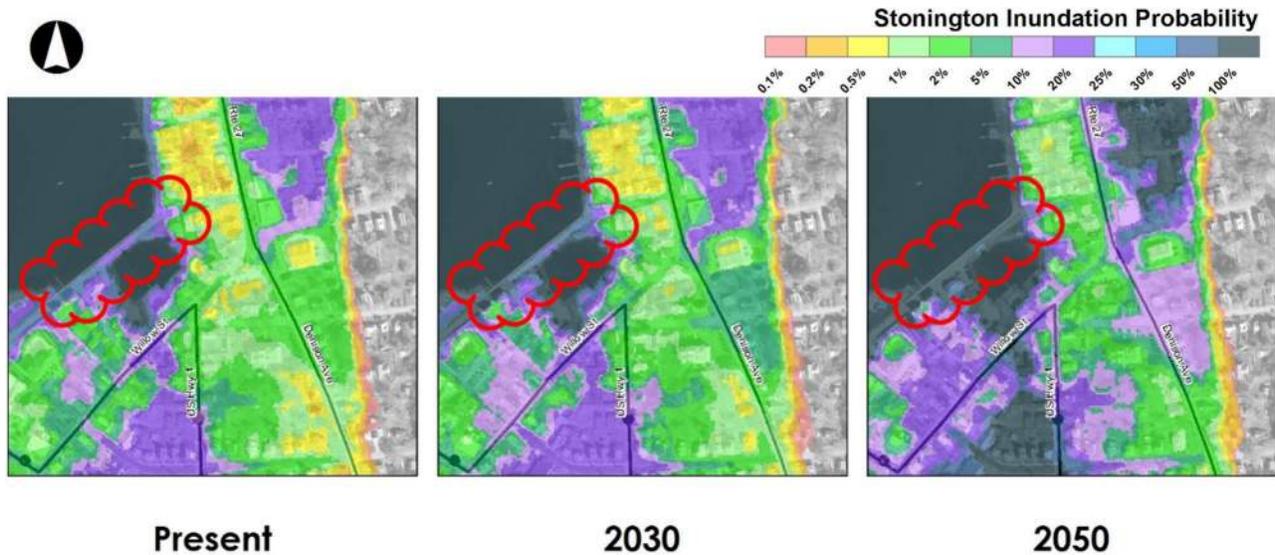
Image 3. Annual Probability of Flooding Maps – Snapshot of Holmes Street – taken from 2017 Town of Stonington Coastal Resilience Plan (Stonington, CT Website)⁴

The report titled, “Town of Stonington Coastal Resilience Plan,” dated August 2017 provides an overview of current and future coastal flood risk, vulnerable community assets, and potential resilience solutions. Within that report, the Mystic neighborhood was identified as one of the most vulnerable to sea level rise and storm surge. Holmes Street was not directly studied as an asset through the plan, but *Image 3* illustrates the annual probability of flooding under current, 2030 (0.55 feet of SLR), and 2050 (1.69 feet of SLR) for the site.

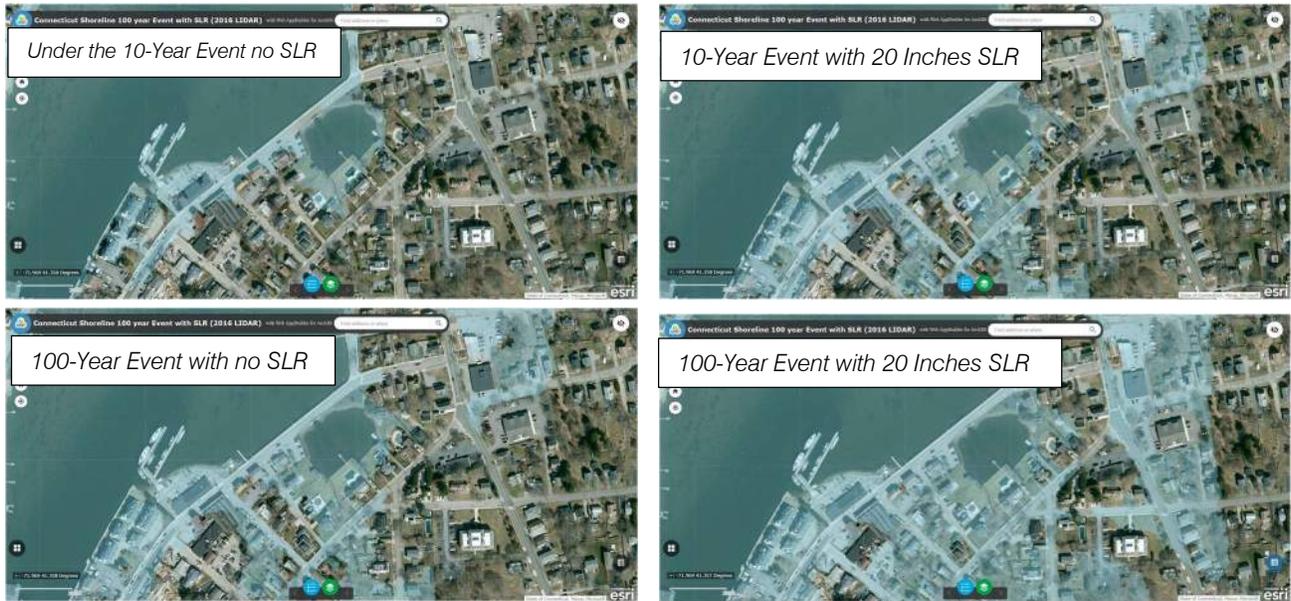
Image 4. Inundated Areas (Shown in Blue) (CIRCA SLR Viewer)⁵

Flood maps were also available through the CIRCA Connecticut Shoreline online Sea Level Rise viewer, which provided scenarios for the 10-year and the 100-year Flood Events with and without 20 inches of SLR as shown in *Image 4*.

These maps indicate that the current 100-year flood event is similar to the 10-year flood event with 20 inches of SLR. In other words, over the next 30 years, the 100-year flood event will be ten times more likely to occur on an annual basis.

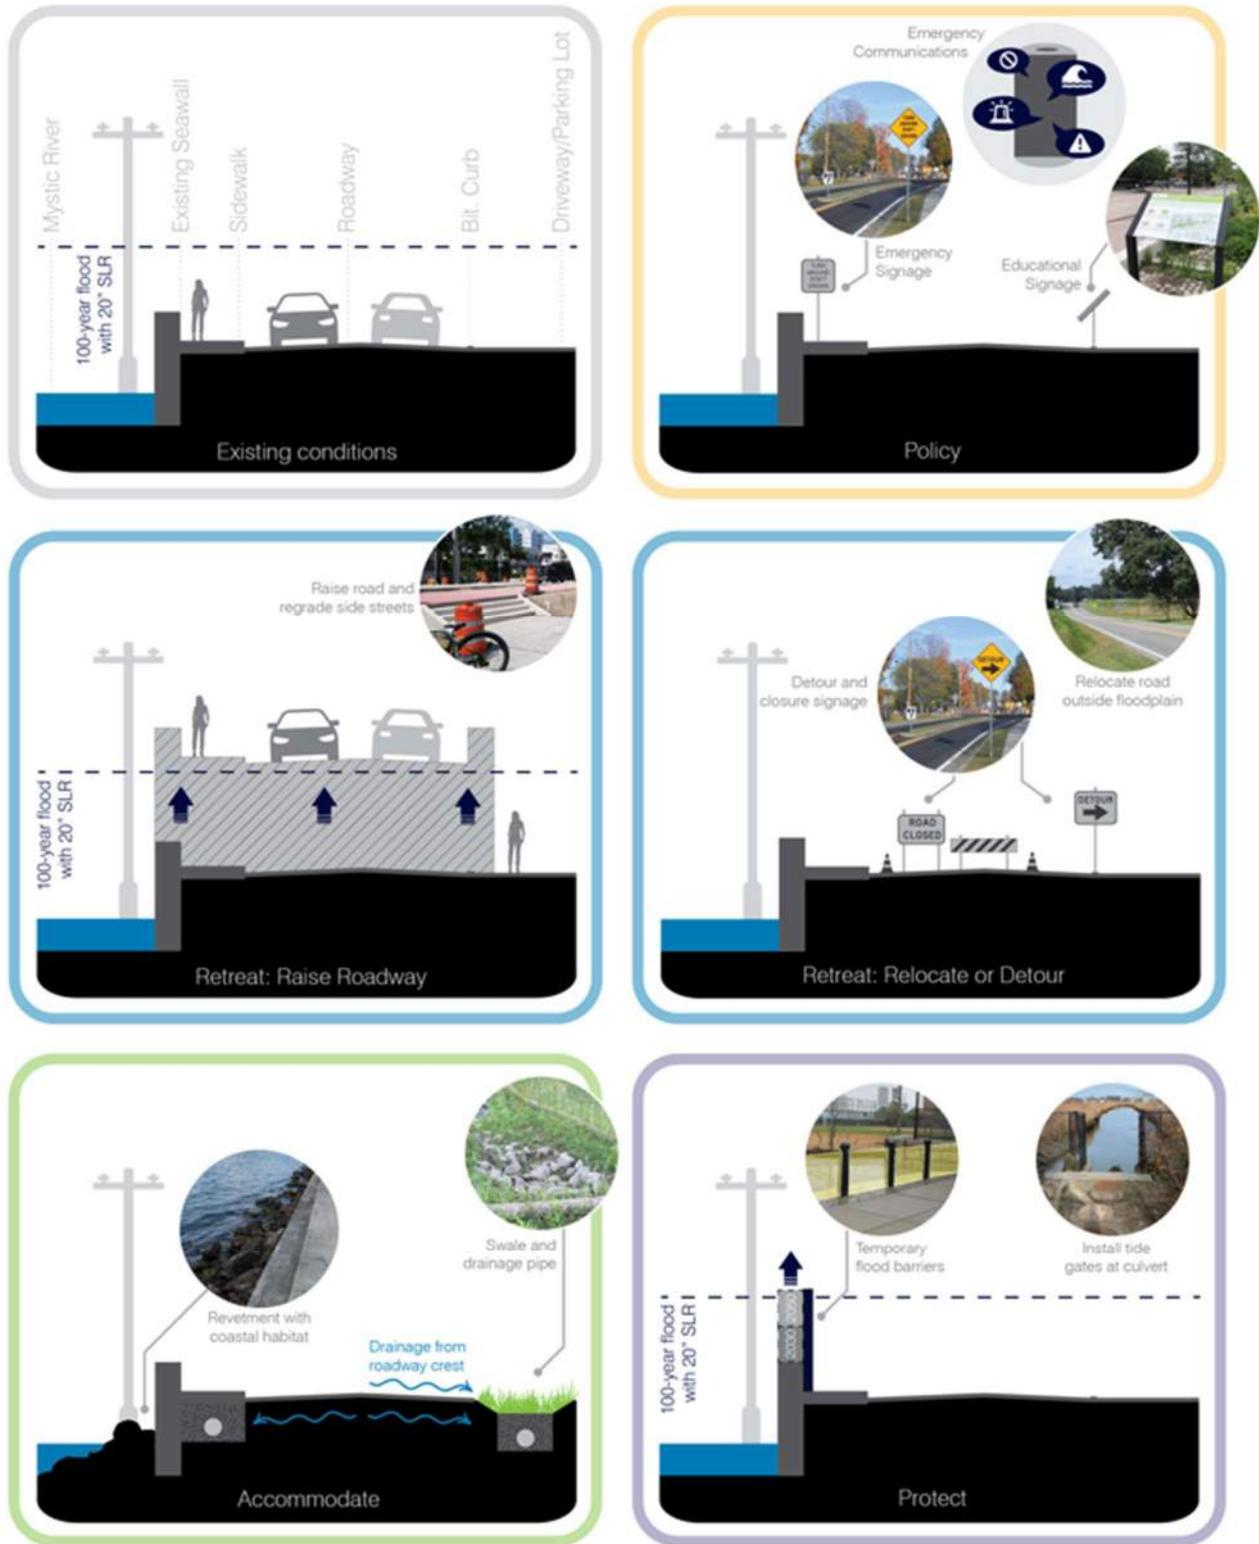
Image 5. Menu of Solutions to Increase Climate Resilience

These strategies are illustrated on *Image 5* on the next page.

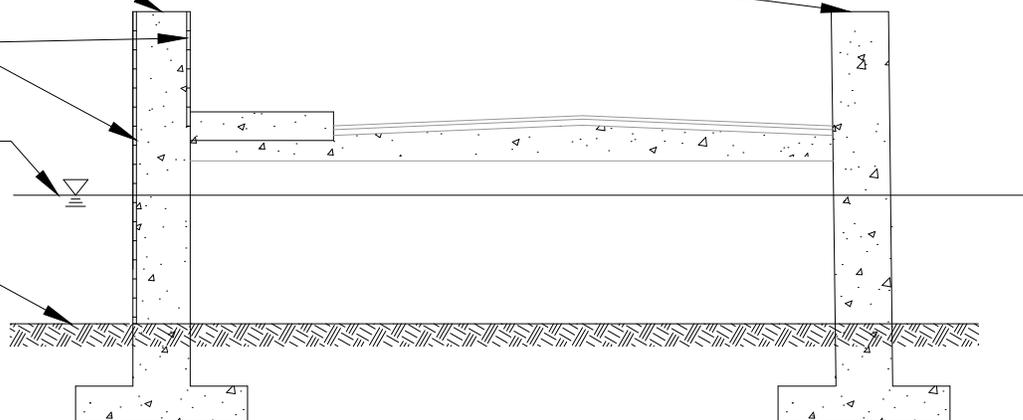
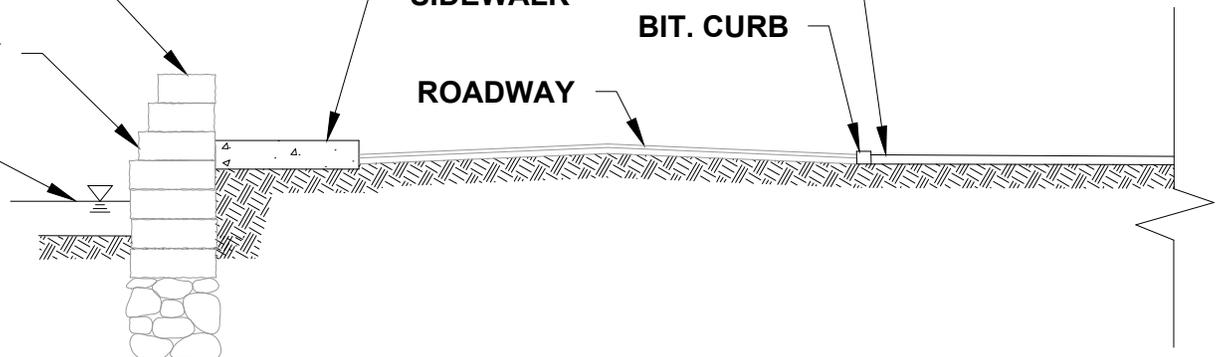
**FIGURE 5
ROADWAY EXISTING CONDITIONS
CROSS SECTIONS**

CULVERT
HEADWALL
FOOTING

SECTION A-A'

The seawall consists of stone masonry which is about 24-inches-wide at the top and widens to about 33 to 36 inches approximately 4 feet below the top of wall. At the northeastern end of the seawall, near the intersection with Bay Street, the last approximately 32 feet of stone masonry wall was constructed out of a different stone masonry and looks to be either an addition or repair to the original stone masonry construction. The seawall has an approximately 1-inch-thick cast-in-place concrete cap. The upper approximately four feet of seawall consists of mortared stone masonry while the remaining lower section was dry stacked masonry stone. These conditions are illustrated on *Figure 5 – Roadway Cross Sections*.

A single span bridge is located at the approximate center of the seawall. Repairs were made to the bridge circa 1999 which included grouting of voids in the existing seawall proximate to the bridge. The culvert headwalls are supported on spread footings as illustrated on *Figure 5*. A copy of the design drawings are included in *Appendix D*.

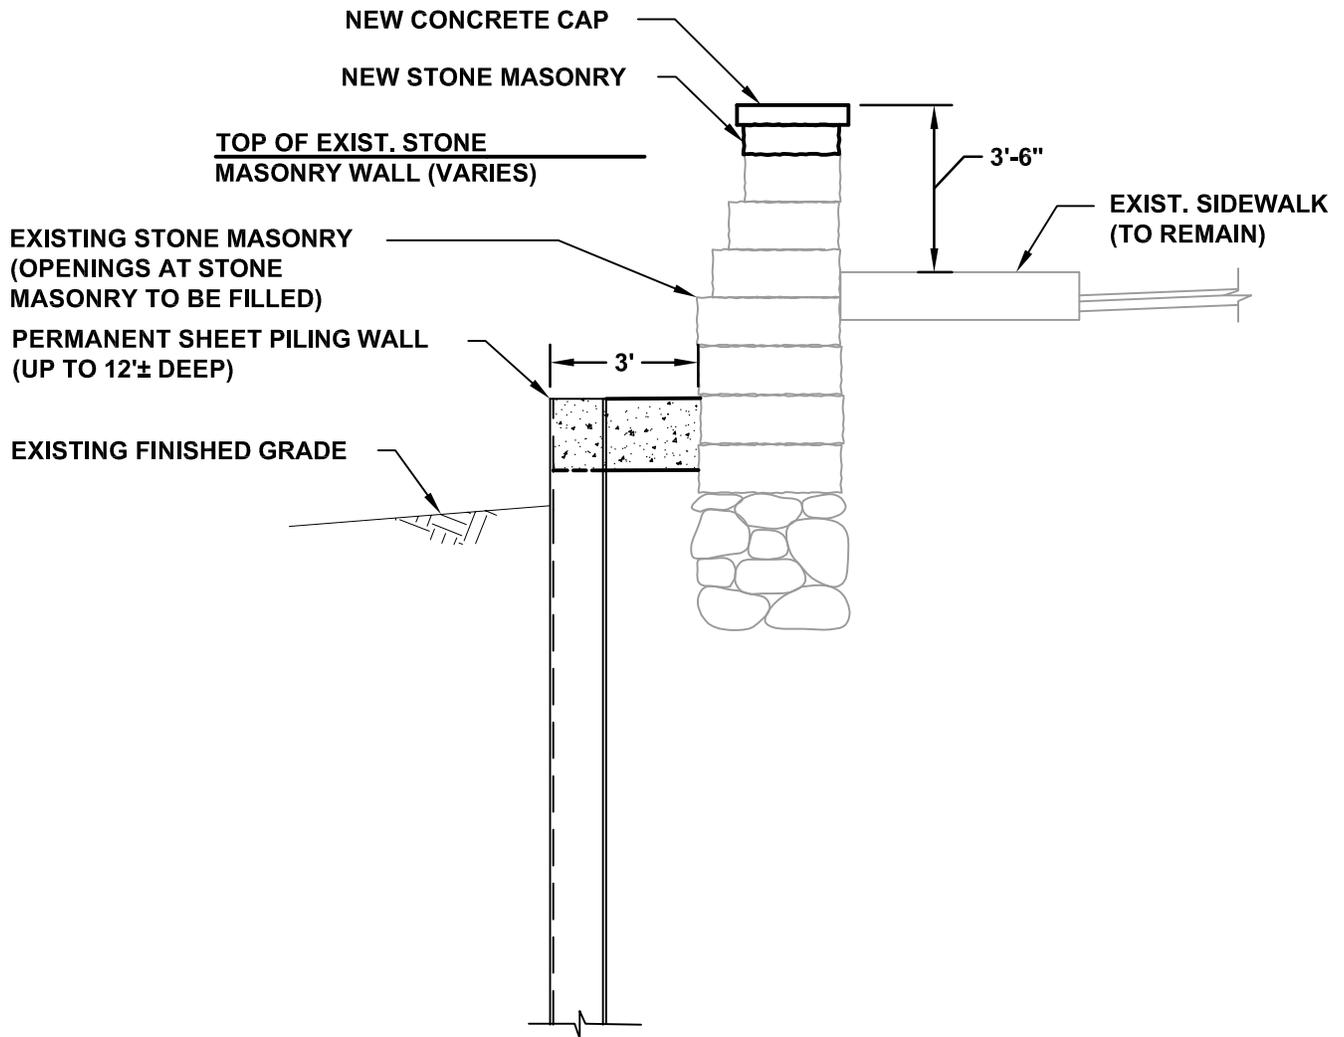
FIGURE 6
SHEET PILE SUPPORT OF
EXISTING WALL SKETCH

The existing seawall could be rehabilitated by installing steel sheet piling in front of the wall as shown on *Figure 6 – Sheet Pile Support of Existing Seawall*. The sheet piles will reduce/eliminate the scour potential and corresponding undermining of the foundation. The gap between the sheet piles and existing seawall will be filled with scour resistant material such as large stone, flowable fill, or concrete. Subsequently, voids between the dry stacked foundation stones can be filled with flowable fill or cement grout. The missing stones from the upper portion of the wall can be replaced. The installation of the sheet piling, repairs and concrete placement can be performed from back of the wall which will require only temporary closure of the existing sidewalk and one-lane of roadway. The traffic will be maintained with one-lane alternating traffic during the construction working hours then at the end of the workday the roadway and sidewalk will be reopened daily.

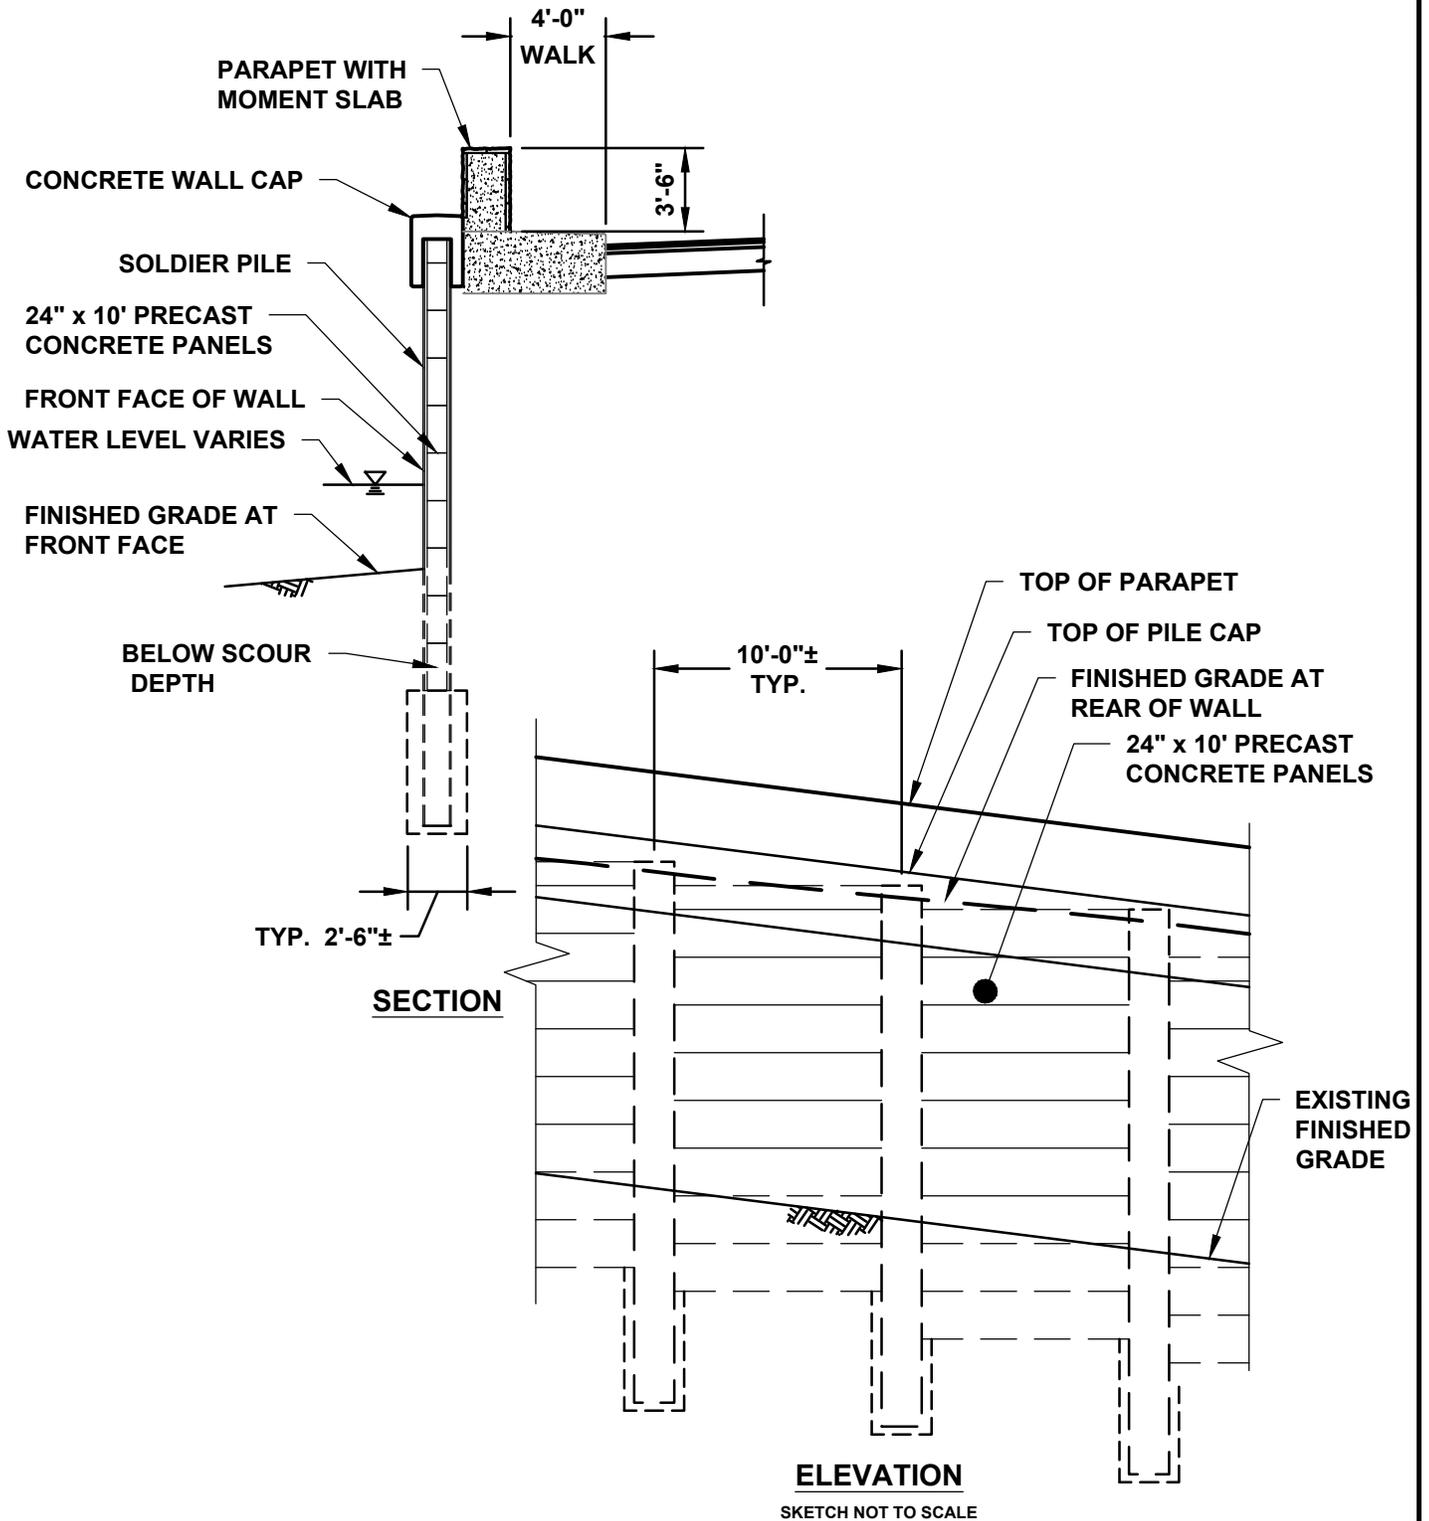
FIGURE 7
SOLDIER PILE LAGGING WALL SKETCH

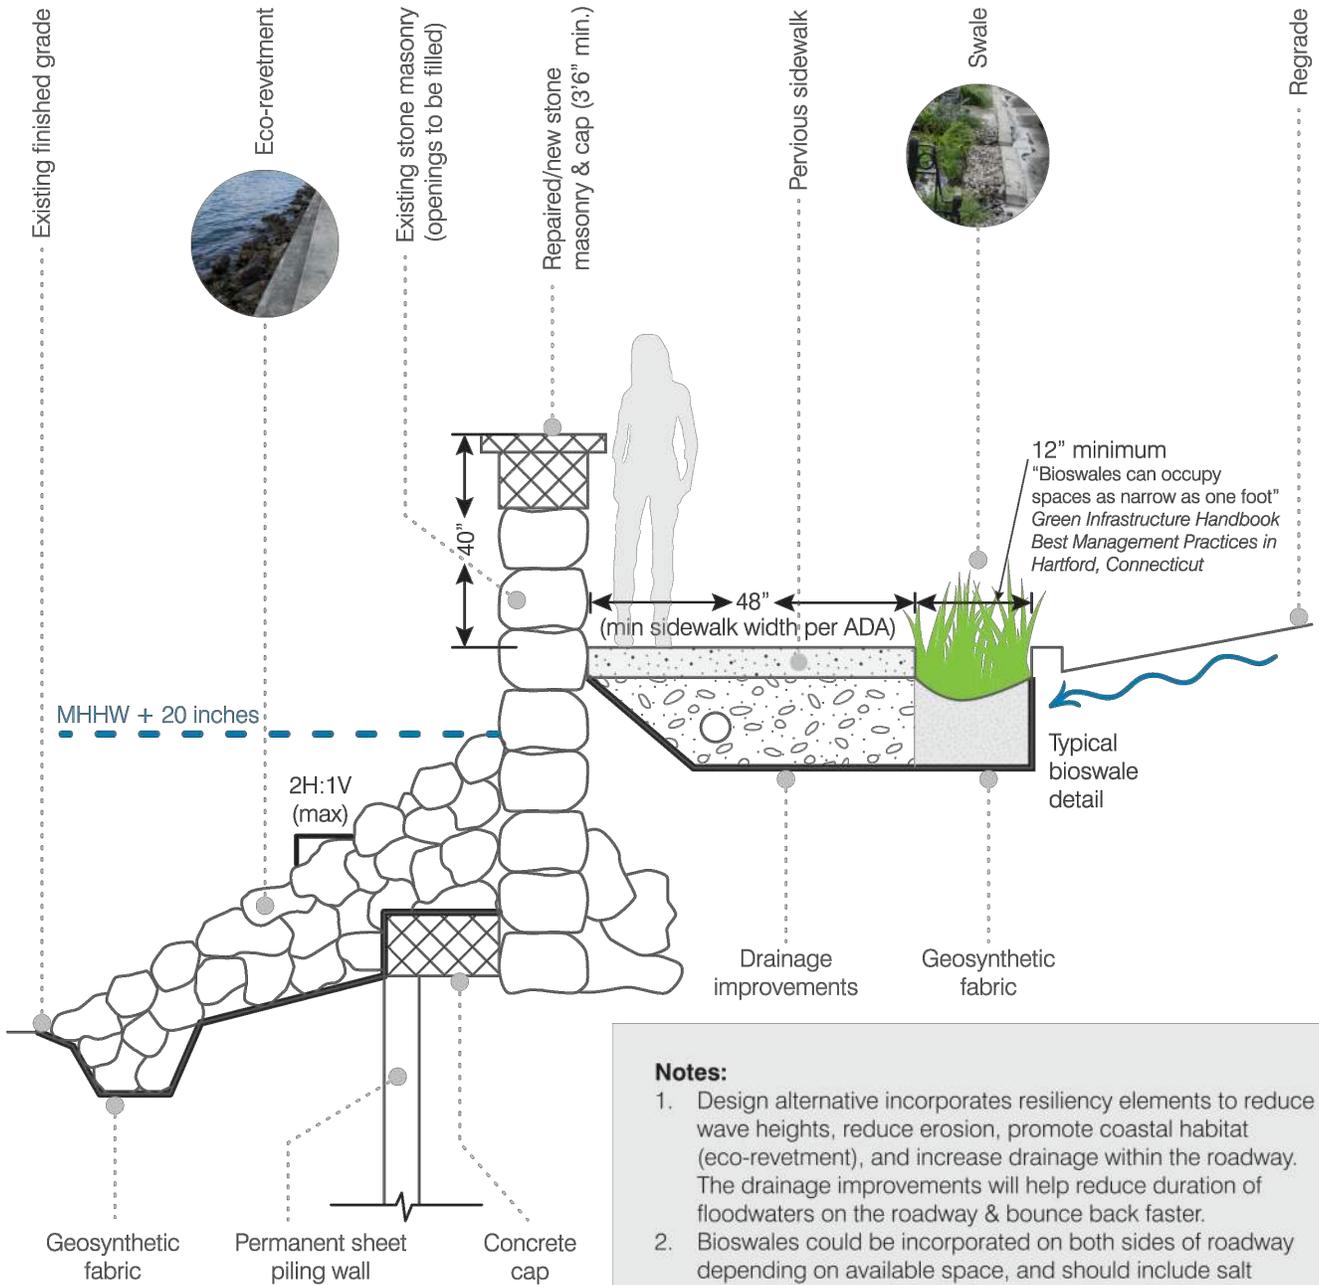
1. Design alternative incorporates resiliency elements to reduce wave heights, reduce erosion, promote coastal habitat (eco-revetment), and increase drainage within the roadway. The drainage improvements will help reduce duration of floodwaters on the roadway & bounce back faster.
2. Bioswales could be incorporated on both sides of roadway depending on available space, and should include salt tolerant plant materials. Sidewalks must be designed to maintain ADA accessibility.
3. The roadway should be regraded to direct flood water to bioswale features. Drainage improvements should collect and convey water away from the seawall to reduce lateral forces on the existing structure.

**FIGURE 9
INCORPORATING RESILIENCY WITH
SUPPORT OF EXISTING SEAWALL**

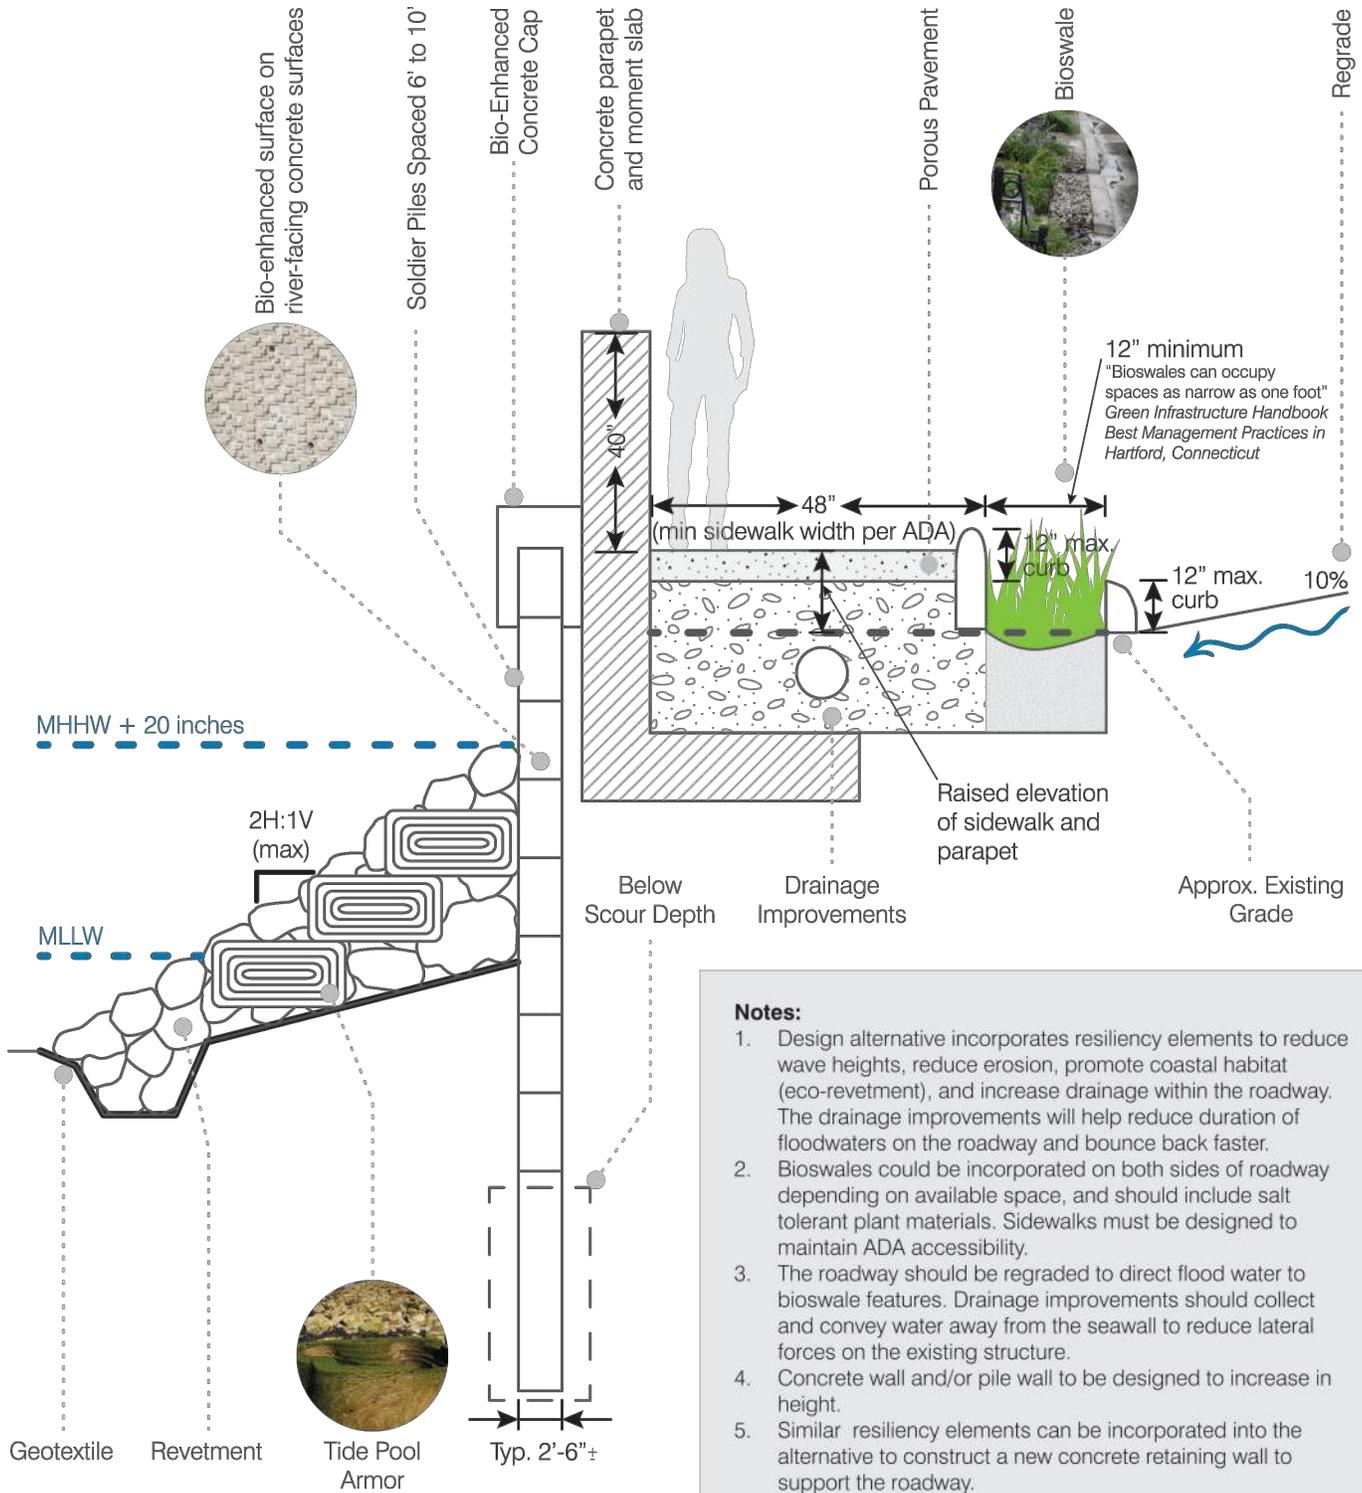
FIGURE 10
INCORPORATING RESILIENCY WITH
RECONSTRUCTION OF THE SEAWALL

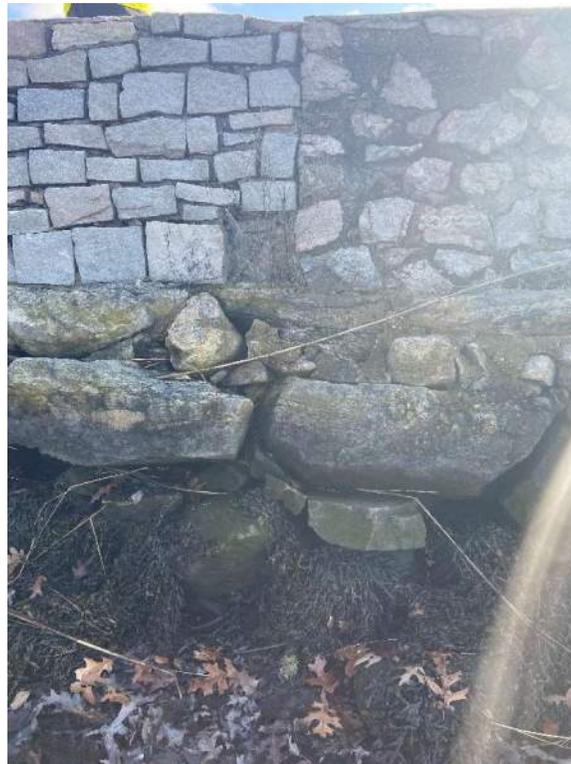
Photo 4: Close up of change in stone masonry

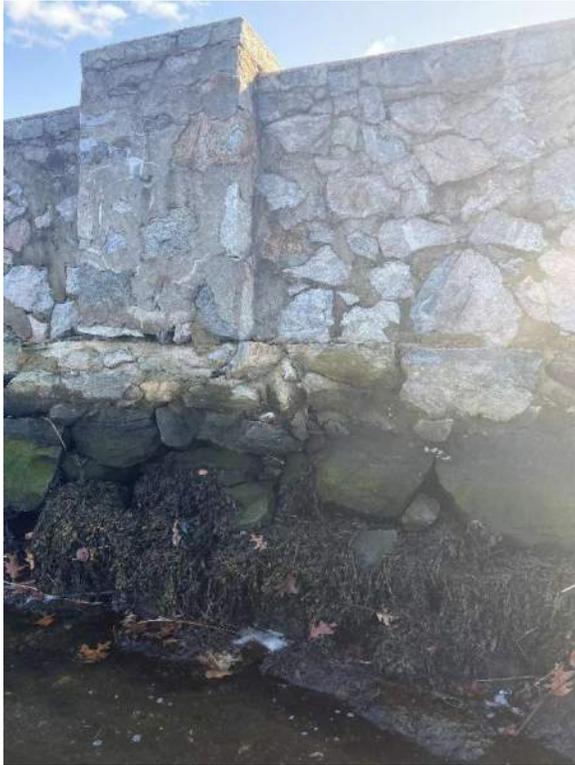
Photo 5: stone masonry pilaster

The seawall had 8 stone masonry pilasters located at various locations along the seawall. The stone pilaster measured 3 feet by x 3 feet with 3.3-foot x 3.3-foot concrete caps. There were several drainage components that penetrate through the seawall and utility poles are located directly adjacent to the seawall in the Mystic River. The height of the seawall was measured from the sidewalk (rearface of the seawall) and found to vary from 27 inches to 42 inches along the seawall length in a septain shape.

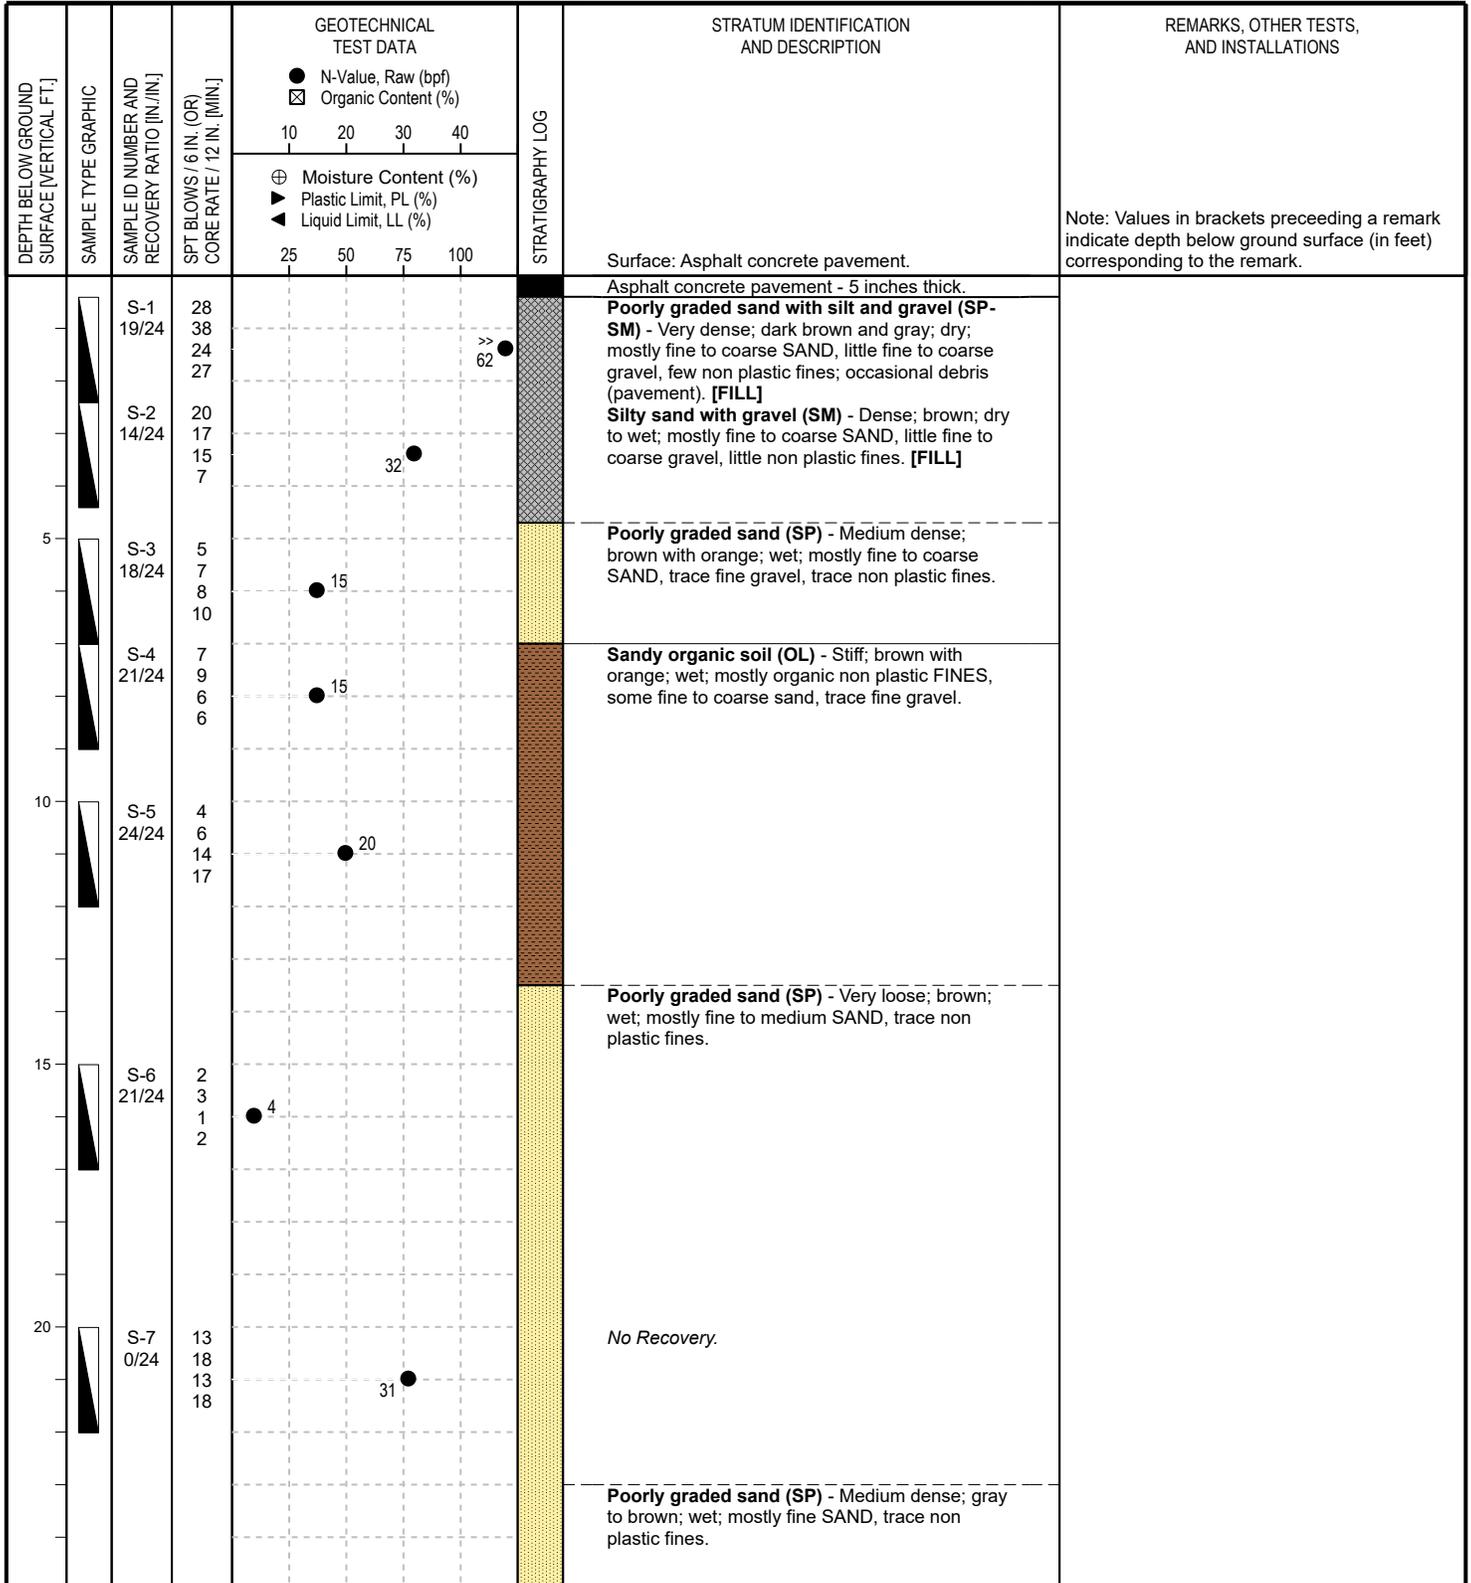
DEPTH BELOW GROUND SURFACE [VERTICAL FT.]	SAMPLE TYPE GRAPHIC	SAMPLE ID NUMBER AND RECOVERY RATIO [IN./IN.]	SPT BLOWS / 6 IN. (OR) CORE RATE / 12 IN. [MIN.]	GEOTECHNICAL TEST DATA				STRATIGRAPHY LOG	STRATUM IDENTIFICATION AND DESCRIPTION	REMARKS, OTHER TESTS, AND INSTALLATIONS
				● N-Value, Raw (bpf)	☒ Organic Content (%)	⊕ Moisture Content (%)	▶ Plastic Limit, PL (%)			
5		S-8 24/24	5							<p>Note: Values in brackets preceding a remark indicate depth below ground surface (in feet) corresponding to the remark.</p>
7			7					<p>Poorly graded sand (SP) - Medium dense; gray to brown; wet; mostly fine SAND, trace non plastic fines.</p>		
8			8							
8			8							
30		S-9 20/24	6							
6			6							
8			8							
6			6							
35		S-10 21/24	7							
7			7							
5			5							
6			6							
40										
45										
50										
									Exploration ended at 35.0 ft.

Subsurface conditions were explored by advancing three borings (B-1, B-2, and B-3/B-3A) and excavating three test pits (TP-1 through TP-3) between November 21 and 22, 2022. Approximate exploration locations are shown in *Figure 2 – Site Plan*. Weston & Sampson geotechnical engineering staff monitored the exploration activities in the field and prepared logs for each exploration. Boring and test pit logs are included in *Appendices B* and *C*, respectively.

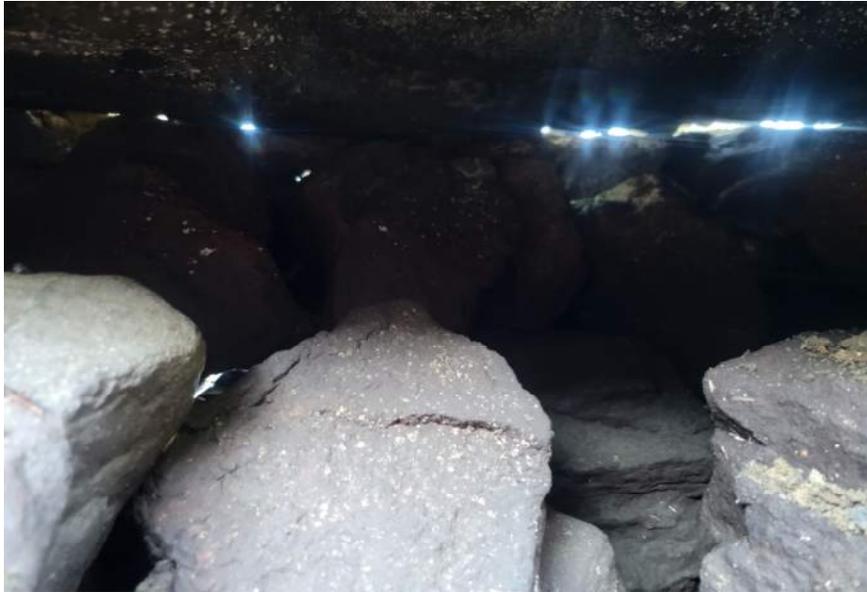
Photo 1: View into void space

The stone masonry joints are in fair condition with minor locations of missing mortar between the stones of various depths. Throughout the inspection, masonry hammers were used to strike the stone, masonry cap, mortar and concrete to assess hollow regions at the cap and wall. Various locations of the concrete cap sounded hollow and observed concrete spalling and cracks were noted throughout the concrete cap. The front face of the seawall, at or below the varying tide waterline, was observed to have missing and shifted stones at various locations. The lower portion of the wall also does not have mortared joints. There was some undermining along the front face (water side) of the wall at various locations. Large voids were observed between the foundation stones in TP-2.

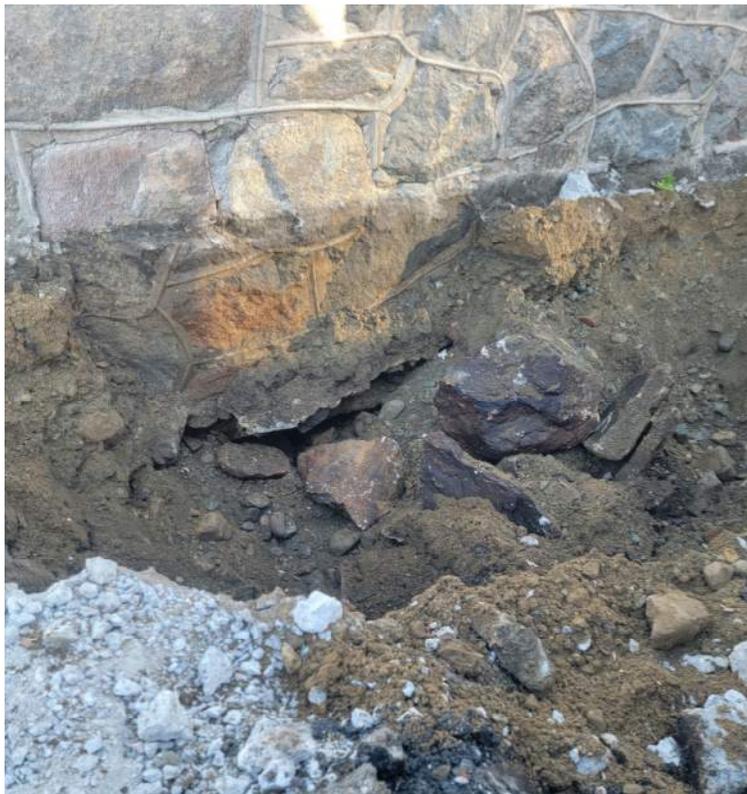
**Photo 2:
Undermined test pit
section of seawall**

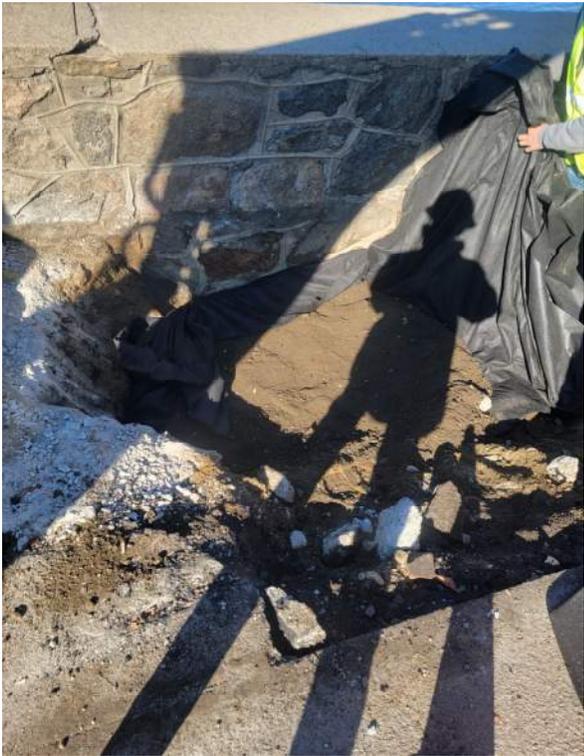
Photo 4: Backfill of test pit with filter fabric, crushed stone, and excavated material

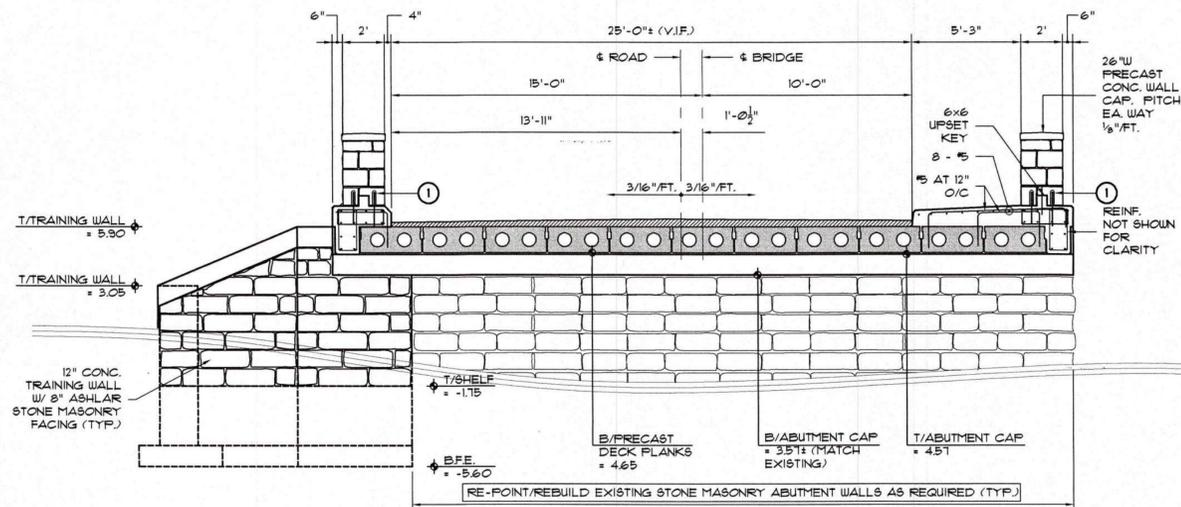
Bridge Section at South Abutment (North Abutment Similar)

SCALE: 1/4" = 1'-0"
 1. 3/8" DULS AT 12" O/C STAGGERED
 FIRE-DRILL 2" DIA. HOLE IN
 ASHLAR STONE MASONRY & GROUT ROD
 SOLID W/ 5 STAR GROUT OR APPROVED
 EQ. MIN EMBED INTO STONE = 12"
 MIN. EMBED INTO CONG. = 12"

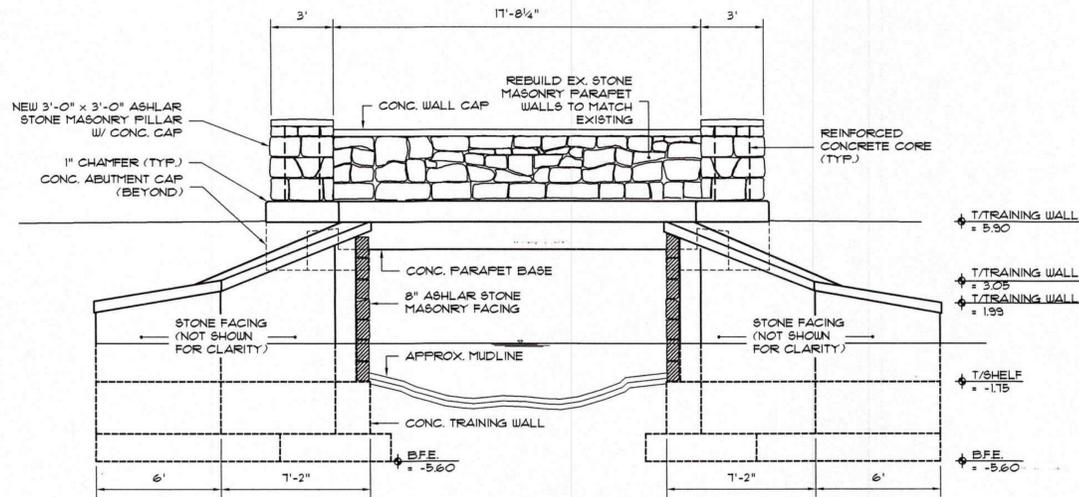
East Elevation
 SCALE: 1/4" = 1'-0"

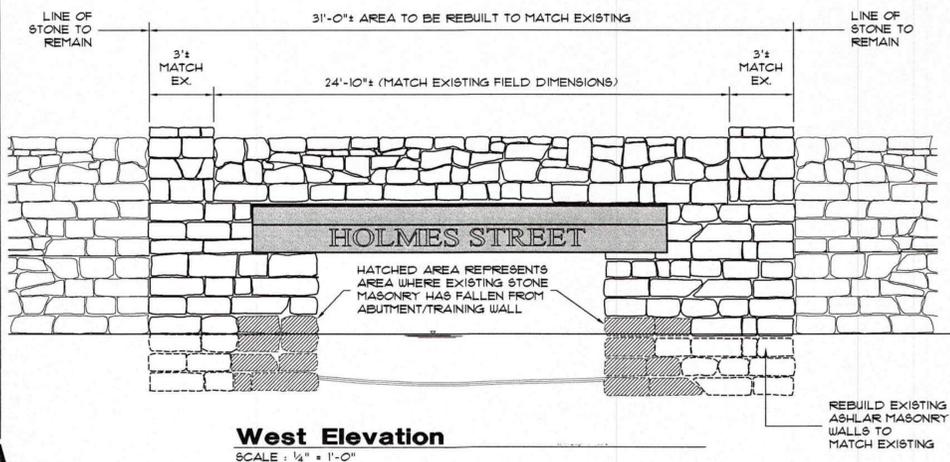
West Elevation
 SCALE: 1/4" = 1'-0"

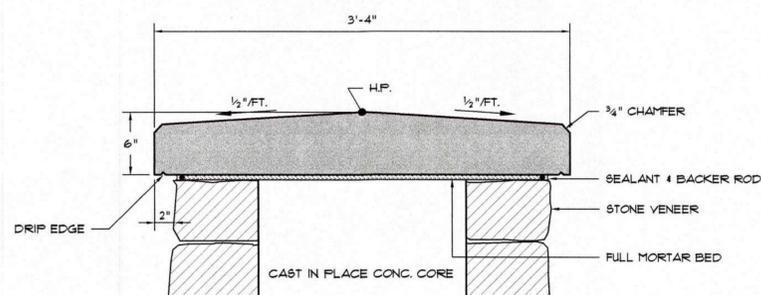
Pre-Cast Conc. Cap Detail

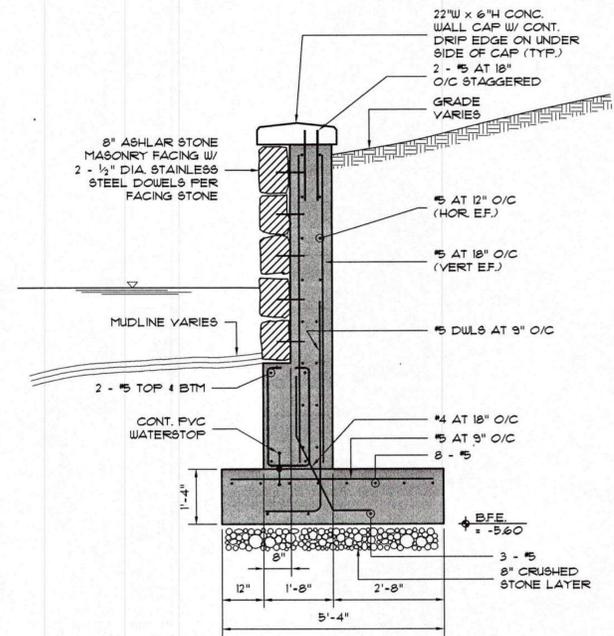
Typical Training Wall Section

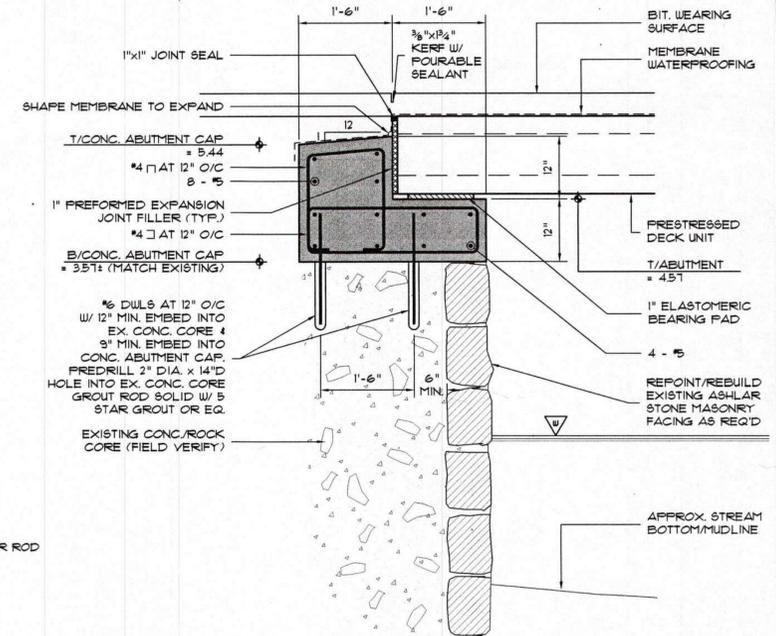
Typical Section Thru Abutment at Bearing
